| (i) | INSPECTING ENGINEER: J. Mark | TY: Georgia Power Company 5, 2024 on Thomas (Georgia P.E. Licens OF THE IMPOUNDING | | (CCR) | | | | | |
|---|--|---|---|---|--|--|--|--|--|
| (i) | ANY CHANGES IN GEOMETRY C STRUCTURE SINCE THE PREVIO | OF THE IMPOUNDING | se #040073) | INSPECTION DATE: November 6, 2024 | | | | | |

INSTRUMENTATION PLAN PLANT YATES ASH POND 2

LOCATION, TYPE, & MAXIMUM RECORDED READINGS OF INSTRUMENTATION YATES ASH POND 2

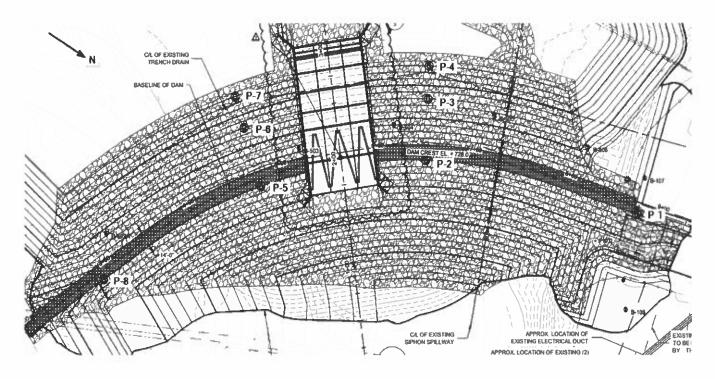
| (i) | INSPECTING ENGINEER: J. Mark | TY: Georgia Power Company 5, 2024 on Thomas (Georgia P.E. Licens OF THE IMPOUNDING | | (CCR) | | | | | |
|---|--|---|---|---|--|--|--|--|--|
| (ii) | LOCATION AND TYPE OF EXIST | See Attached Plan | | | | | | | |
