**VOLUNTARY REMEDIATION PROGRAM
COMPLIANCE STATUS REPORT**

**GEORGIA POWER COMPANY PLANT KRAFT
155 Crossgate Road
PORT WENTWORTH, CHATHAM COUNTY, GEORGIA
HSI Site 10415**

**Resolute Environmental & Water Resources Consulting, LLC
1003 Weatherstone Parkway, Suite 320
Woodstock, GA 30188**

June 15, 2018

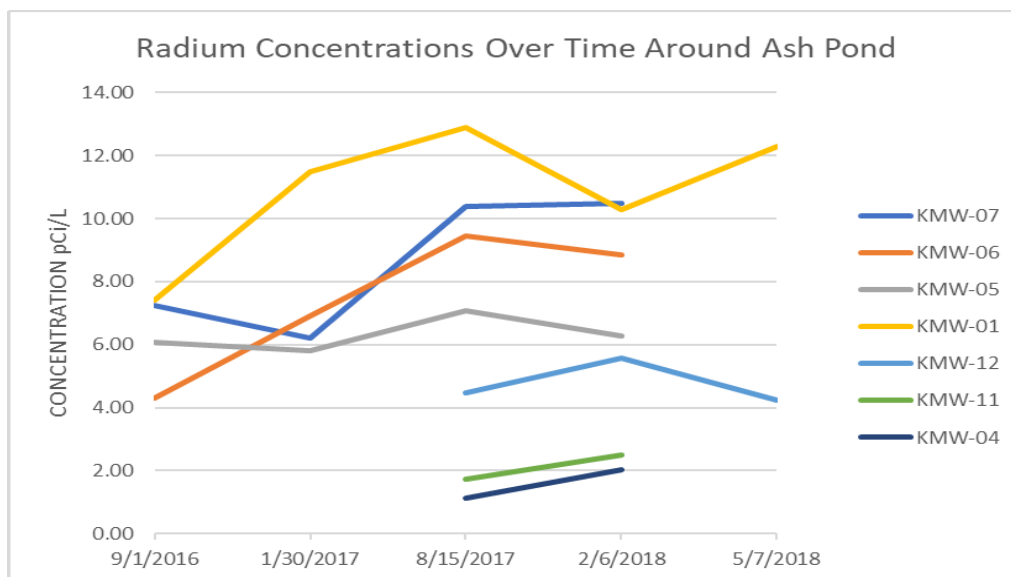
In a fifth monitoring well, KMW-12, radium concentrations slightly exceeded 5 pCi/L in one of three sampling events. Radium was initially detected at a concentration less than 5 pCi/L (4.47 pCi/L) in August 2017 and was then detected at a concentration of 5.57 pCi/L in the February 2018 sampling event. However, the exceedance was not confirmed in the most recent, May 2018 sample with a concentration of 4.24 pCi/L.

The following graph illustrates the radium concentrations in these wells over time:

The groundwater monitoring wells shown on the graph above are either adjacent to or on the hydraulically down-gradient sides of the former ash pond during the 2016, 2017, and 2018 groundwater sampling events. As shown on the graph above, wells KMW-01, -06, and -07 have the highest total radium concentrations on site, and they also had the greatest increase in radium concentrations over time. These same wells had the greatest decrease in pH (greater than 1 S.U.) after closure of the ash pond and the lowest resulting pH of groundwater on the site, with values from 4.0 to 4.8 pH units. There is a direct correlation between the decrease in pH and the increase in radium (primarily radium 228) in these wells. Prior researchers have also noted this relationship. The presence of radium in groundwater is enhanced in aquifers with acidic, anoxic, or both conditions (Both are present in these wells around the former ash pond). Combined radium concentrations exceeding the MCL in drinking water aquifers were most common with those groundwater conditions (*Occurrence and Geochemistry of Radium in Water from Principal Drinking-Water Aquifer Systems of the United States*, Applied Geochemistry, v. 27, 2012; Appendix B).

The decreasing pH in groundwater around the former ash pond after excavation and closure may be a geochemical result of the disturbance caused by the excavation activities, and this situation, in combination with the anoxic conditions, may have secondarily mobilized the naturally-occurring radium.

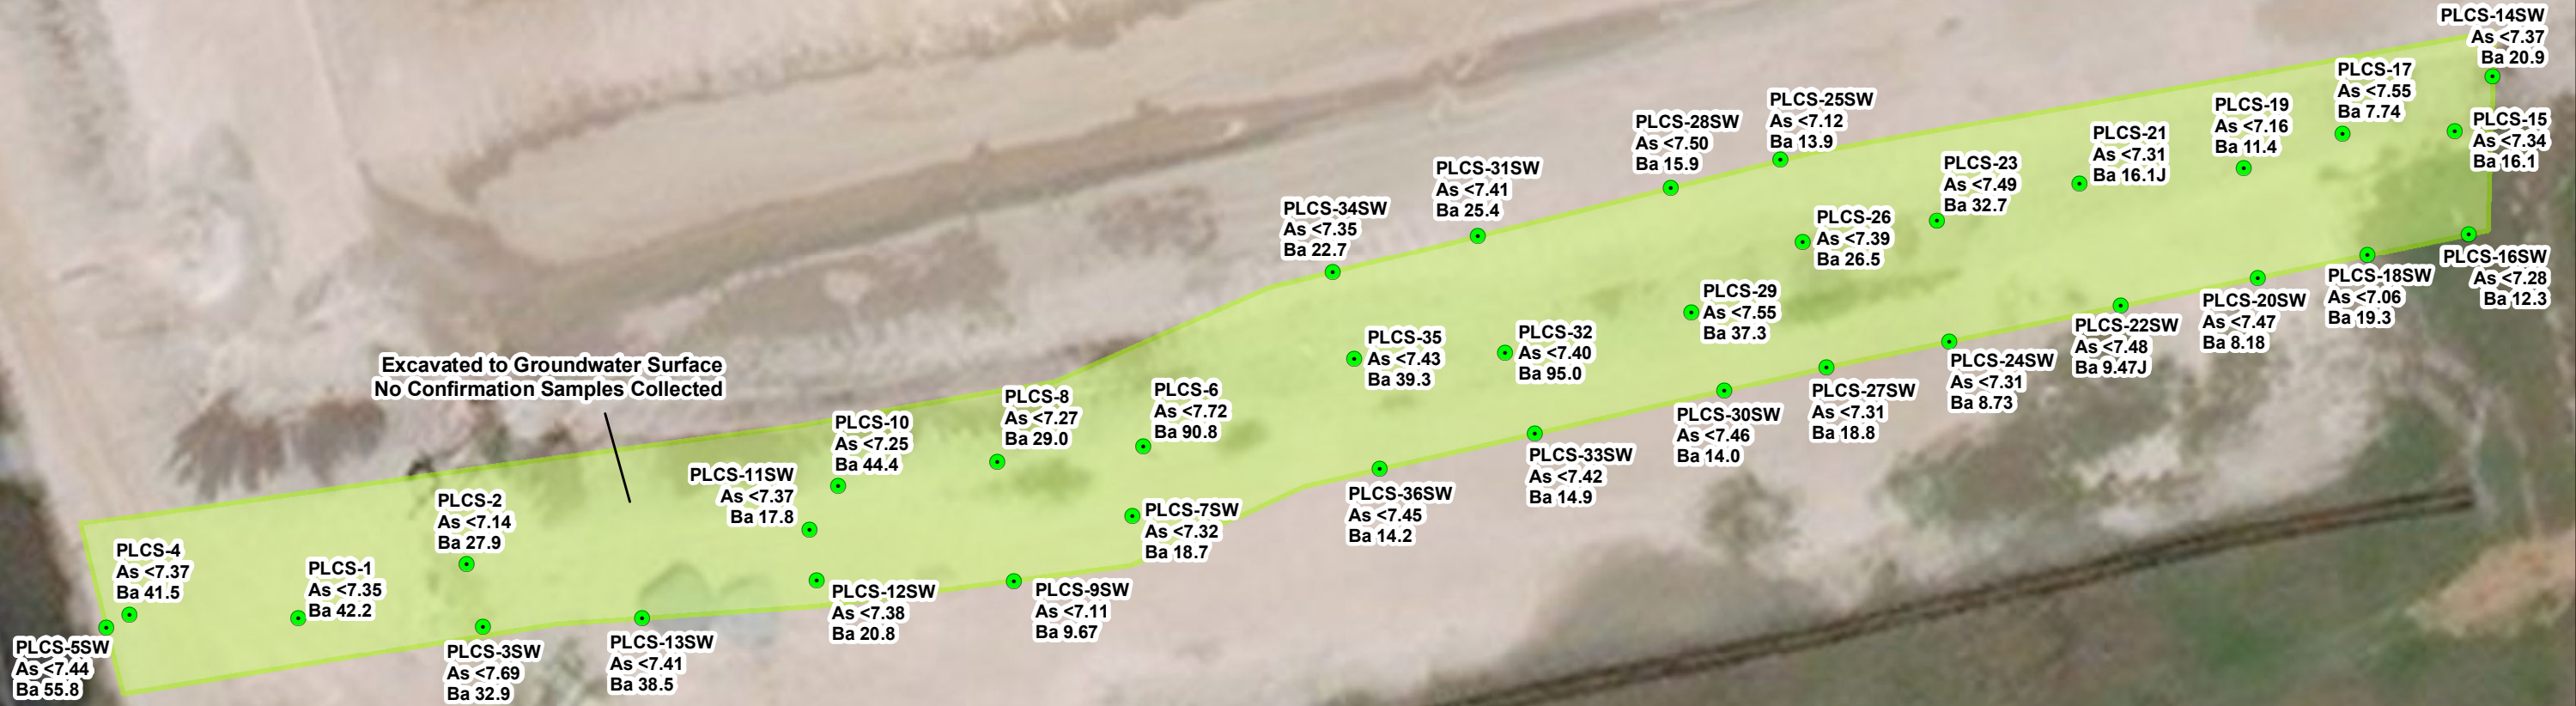
Plant Kraft Excavation Confirmation Sample Results Parking Lot Area	Figure 17

Notes:
 See Analytical Data Summary Table for greater detail.
 Analytical results are reported in mg/kg.
 ≤ indicates the analyte was not detected above the laboratory reporting limit.
 J value indicates analyte was detected between laboratory method detection limit and laboratory reporting limit.

During previous excavation activities and through interviews with past and present GPC employees, ash was reported to be present in the area around the current lay-down yard. A 50-foot grid was established, and DPT boring were advanced to depths of 12 to 16 feet, depending on depth to groundwater and soils observed. Each soil interval was visually observed and logged by a Resolute Staff Professional. In areas that ash was observed above the groundwater surface, adjacent borings were installed to delineate the ash horizontally. Refer to Figure 5 for the parking lot DPT boring locations.

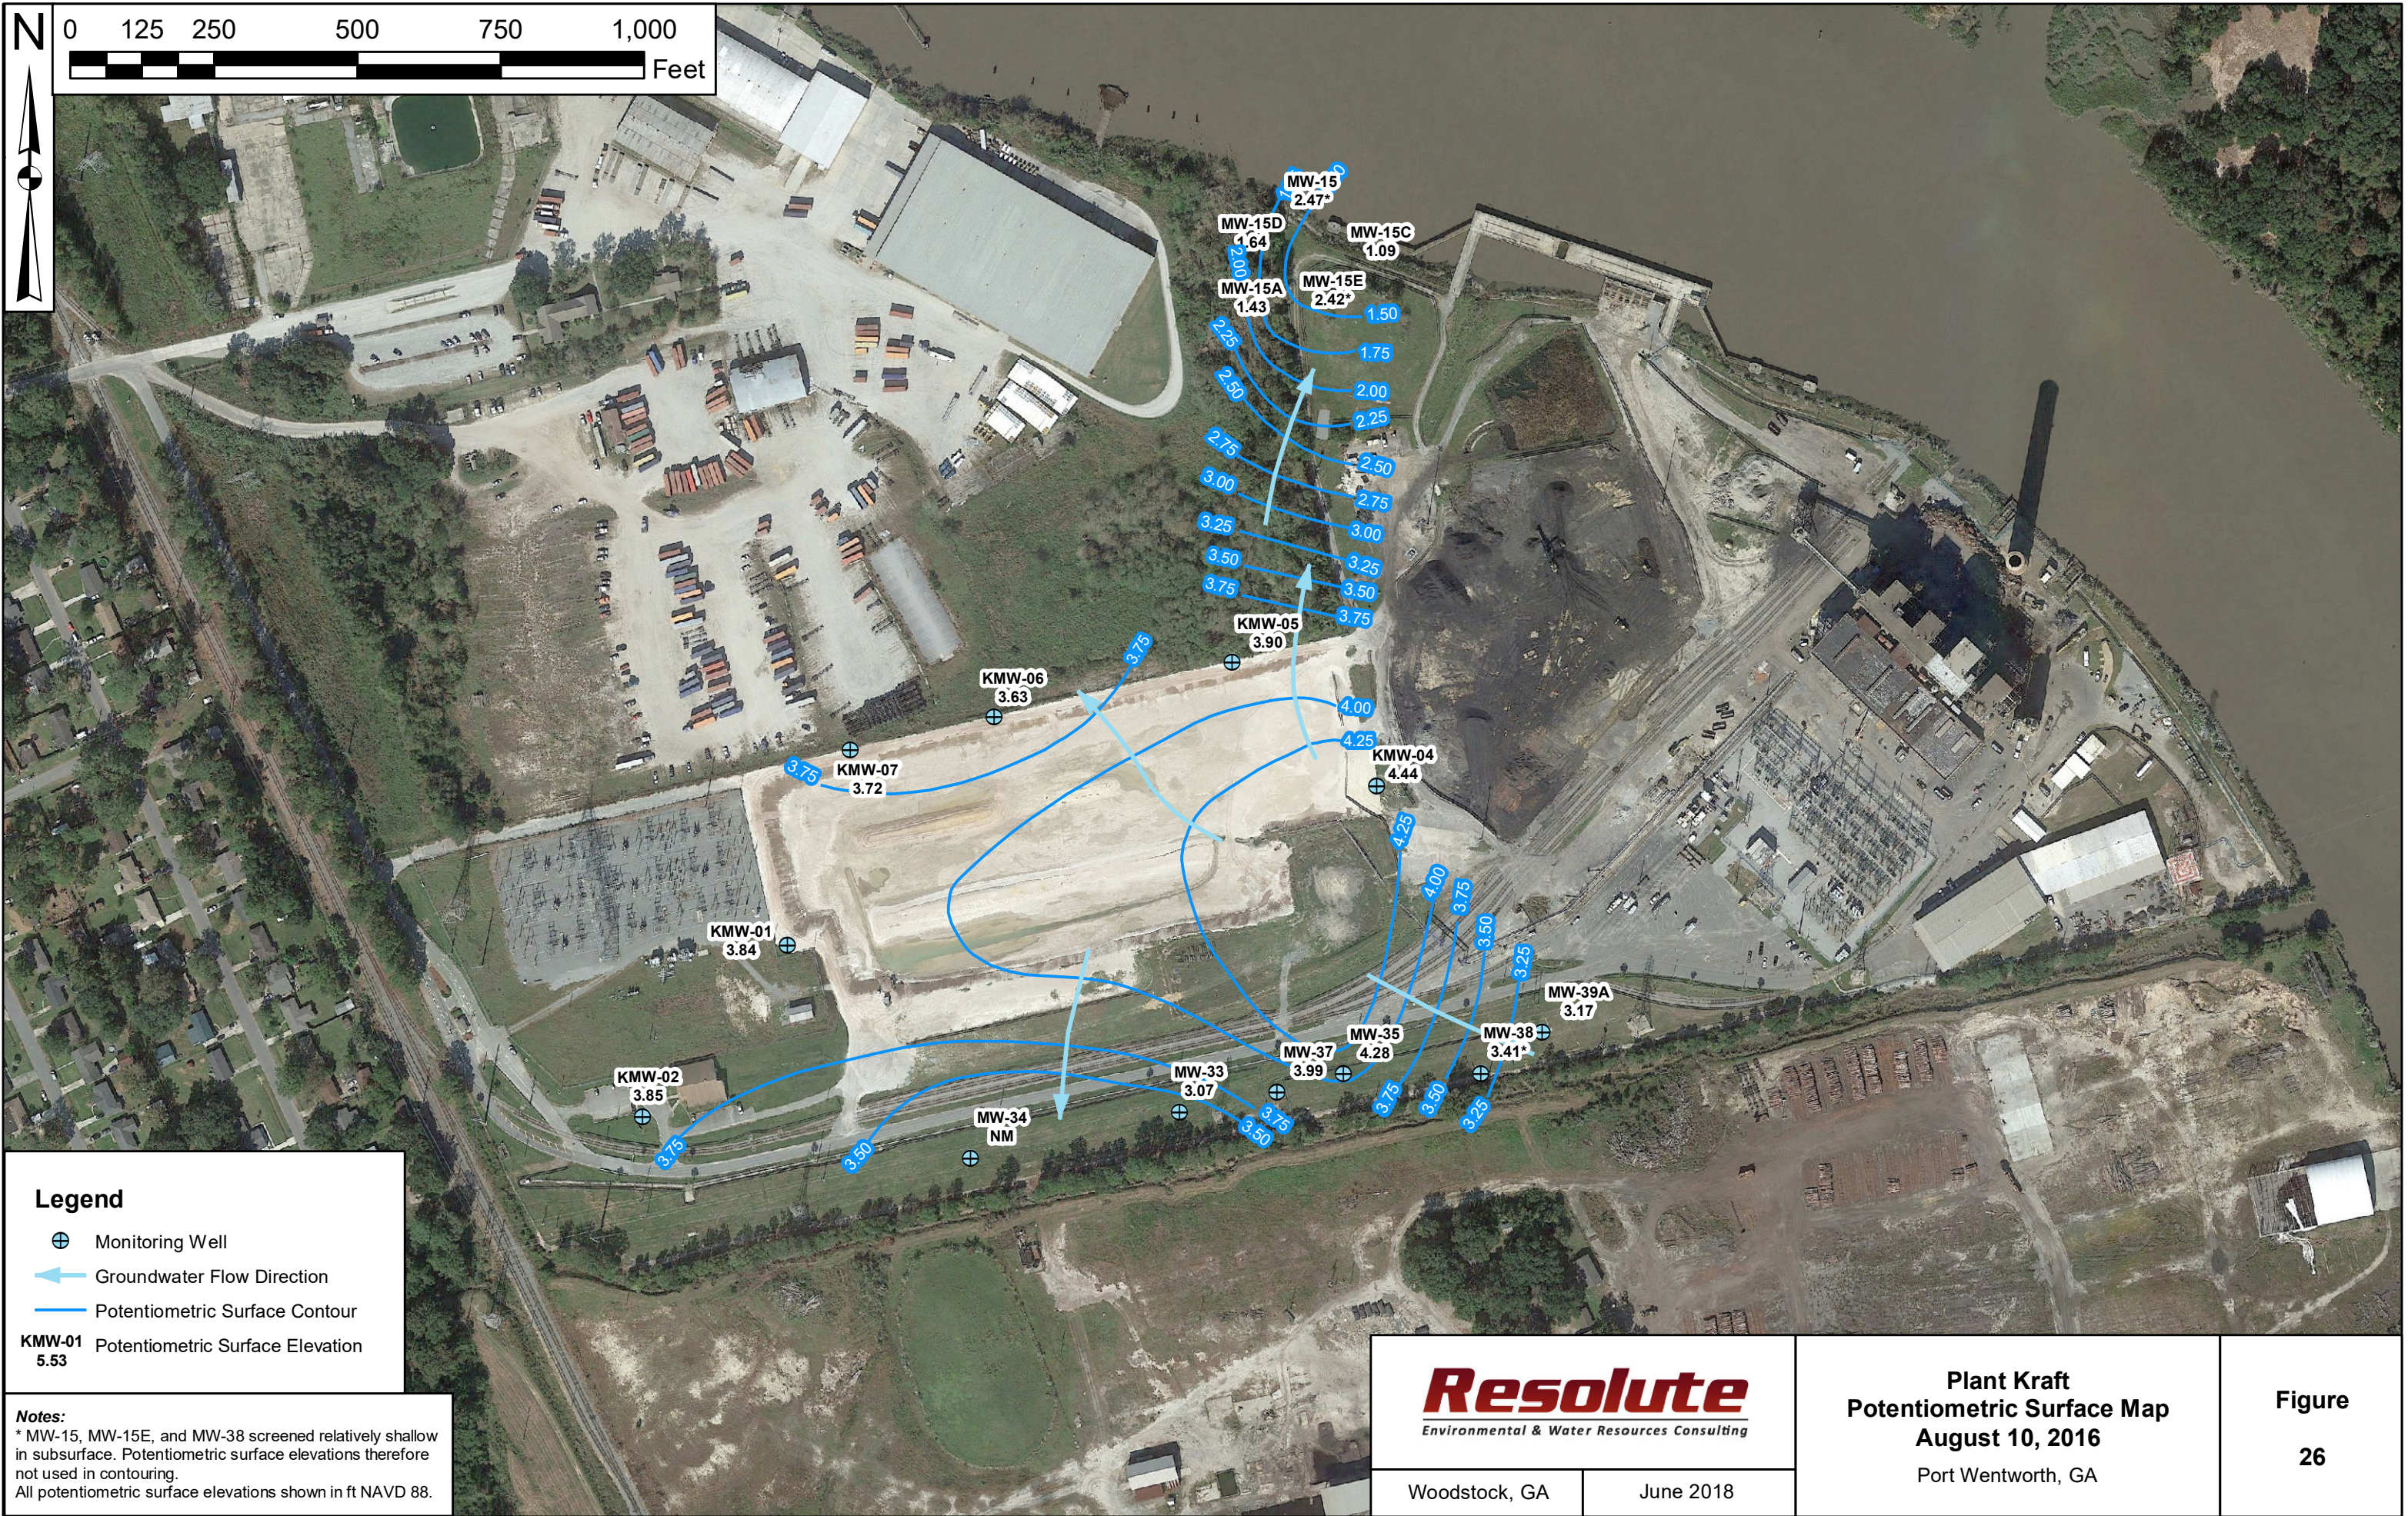
**Figure
 26**

- ⊕ Monitoring Well
- ← Groundwater Flow Direction
- Potentiometric Surface Contour

**Plant Kraft
 Potentiometric Surface Map
 August 10, 2016
 Port Wentworth, GA**
