Name of Document: VRP Revised Compliance Status Report

Site Name: Georgia Power Plant Kraft

Subject: Response to EPD Comments
Voluntary Remediation Program Compliance Status Report
Savannah Electric - Plant Kraft, HSI Site No. 10415
155 Crossgate Road, Port Wentworth, Chatham County, Georgia

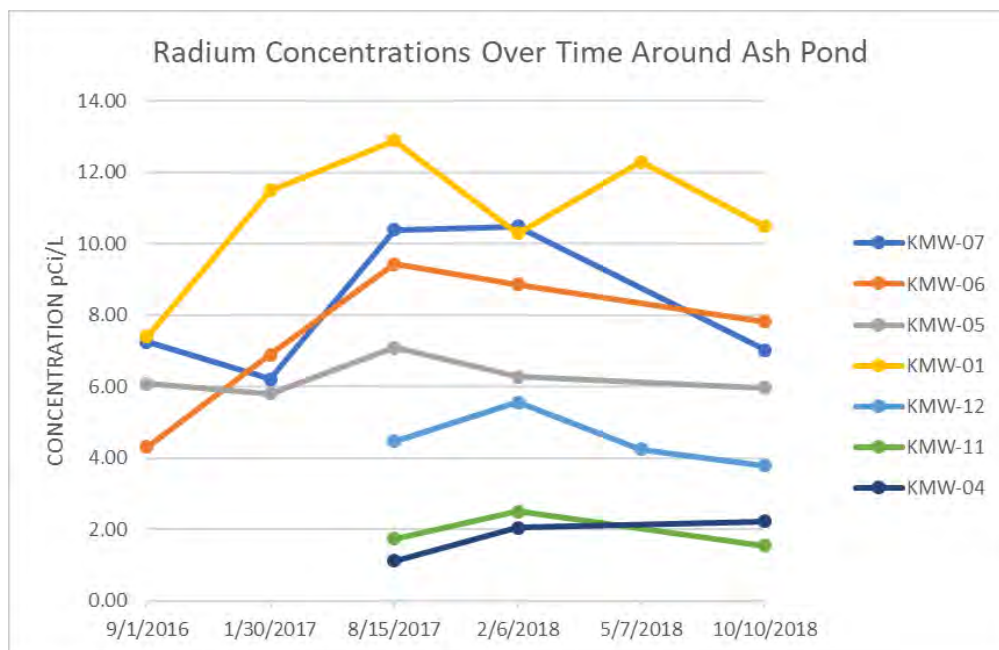
In October 2018, Resolute conducted an additional groundwater monitoring event for radium utilizing the KMW series wells as requested by EPD. During the October 2018 groundwater sampling event, radium concentrations were generally lower than the February 2018 event. Wells KMW-01, KMW-05, KMW-06 and KMW-07 exceeded the MCL for radium, with the bulk of the concentrations being composed of Radium 228 (Table 5).

The following graph illustrates the radium concentrations in these wells over time:

The groundwater monitoring wells shown on the graph above are either adjacent to or on the hydraulically down-gradient sides of the former ash pond during the 2016, 2017, and 2018 groundwater sampling events. As shown on the graph above, wells KMW-01, -06, and -07 have the highest total radium concentrations on site, and they also had the greatest increase in radium concentrations over time. These same wells had the greatest decrease in pH (greater than 1 S.U.) after closure of the ash pond and the lowest resulting pH of groundwater on the site, with values from 4.0 to 4.8 pH units. There is a direct correlation between the decrease in pH and the increase in radium (primarily radium 228) in these wells. Prior researchers have also noted this relationship. The presence of radium in groundwater is enhanced in aquifers with acidic, anoxic, or both conditions (Both are present in these wells around the former ash pond). Combined radium concentrations exceeding the MCL in drinking water aquifers were most common with those groundwater conditions (*Occurrence and Geochemistry of Radium in*

The decreasing pH in groundwater around the former ash pond after excavation and closure may be a geochemical result of the disturbance caused by the excavation activities, and this situation, in combination with the anoxic conditions, may have secondarily mobilized the naturally-occurring radium.

Groundwater on Tract 1 is impacted by total radium concentrations exceeding the EPA at-the-tap MCL in wells KMW-05, -06, and -07. The radium in these wells, and in well KMW-01 on Tract 2, is approximately 80 percent radium 228, with the remainder radium 226. The radium 226 concentrations in these wells are significantly below the MCL of 5 pCi/L. The presence of the radium 228 is causing the MCL to be exceeded and is consistent with the low pH and anoxic conditions in these wells. The radium 228 is also consistent with the dissolution of the naturally-occurring mineral monazite by low pH groundwater around the former ash pond. The lower the pH, the greater the concentration of radium 228 detected.

The decreasing pH in groundwater in certain areas may be a geochemical result of the disturbance caused by the excavation activities, and this situation, in combination with the anoxic conditions, may have secondarily mobilized the naturally-occurring radium.

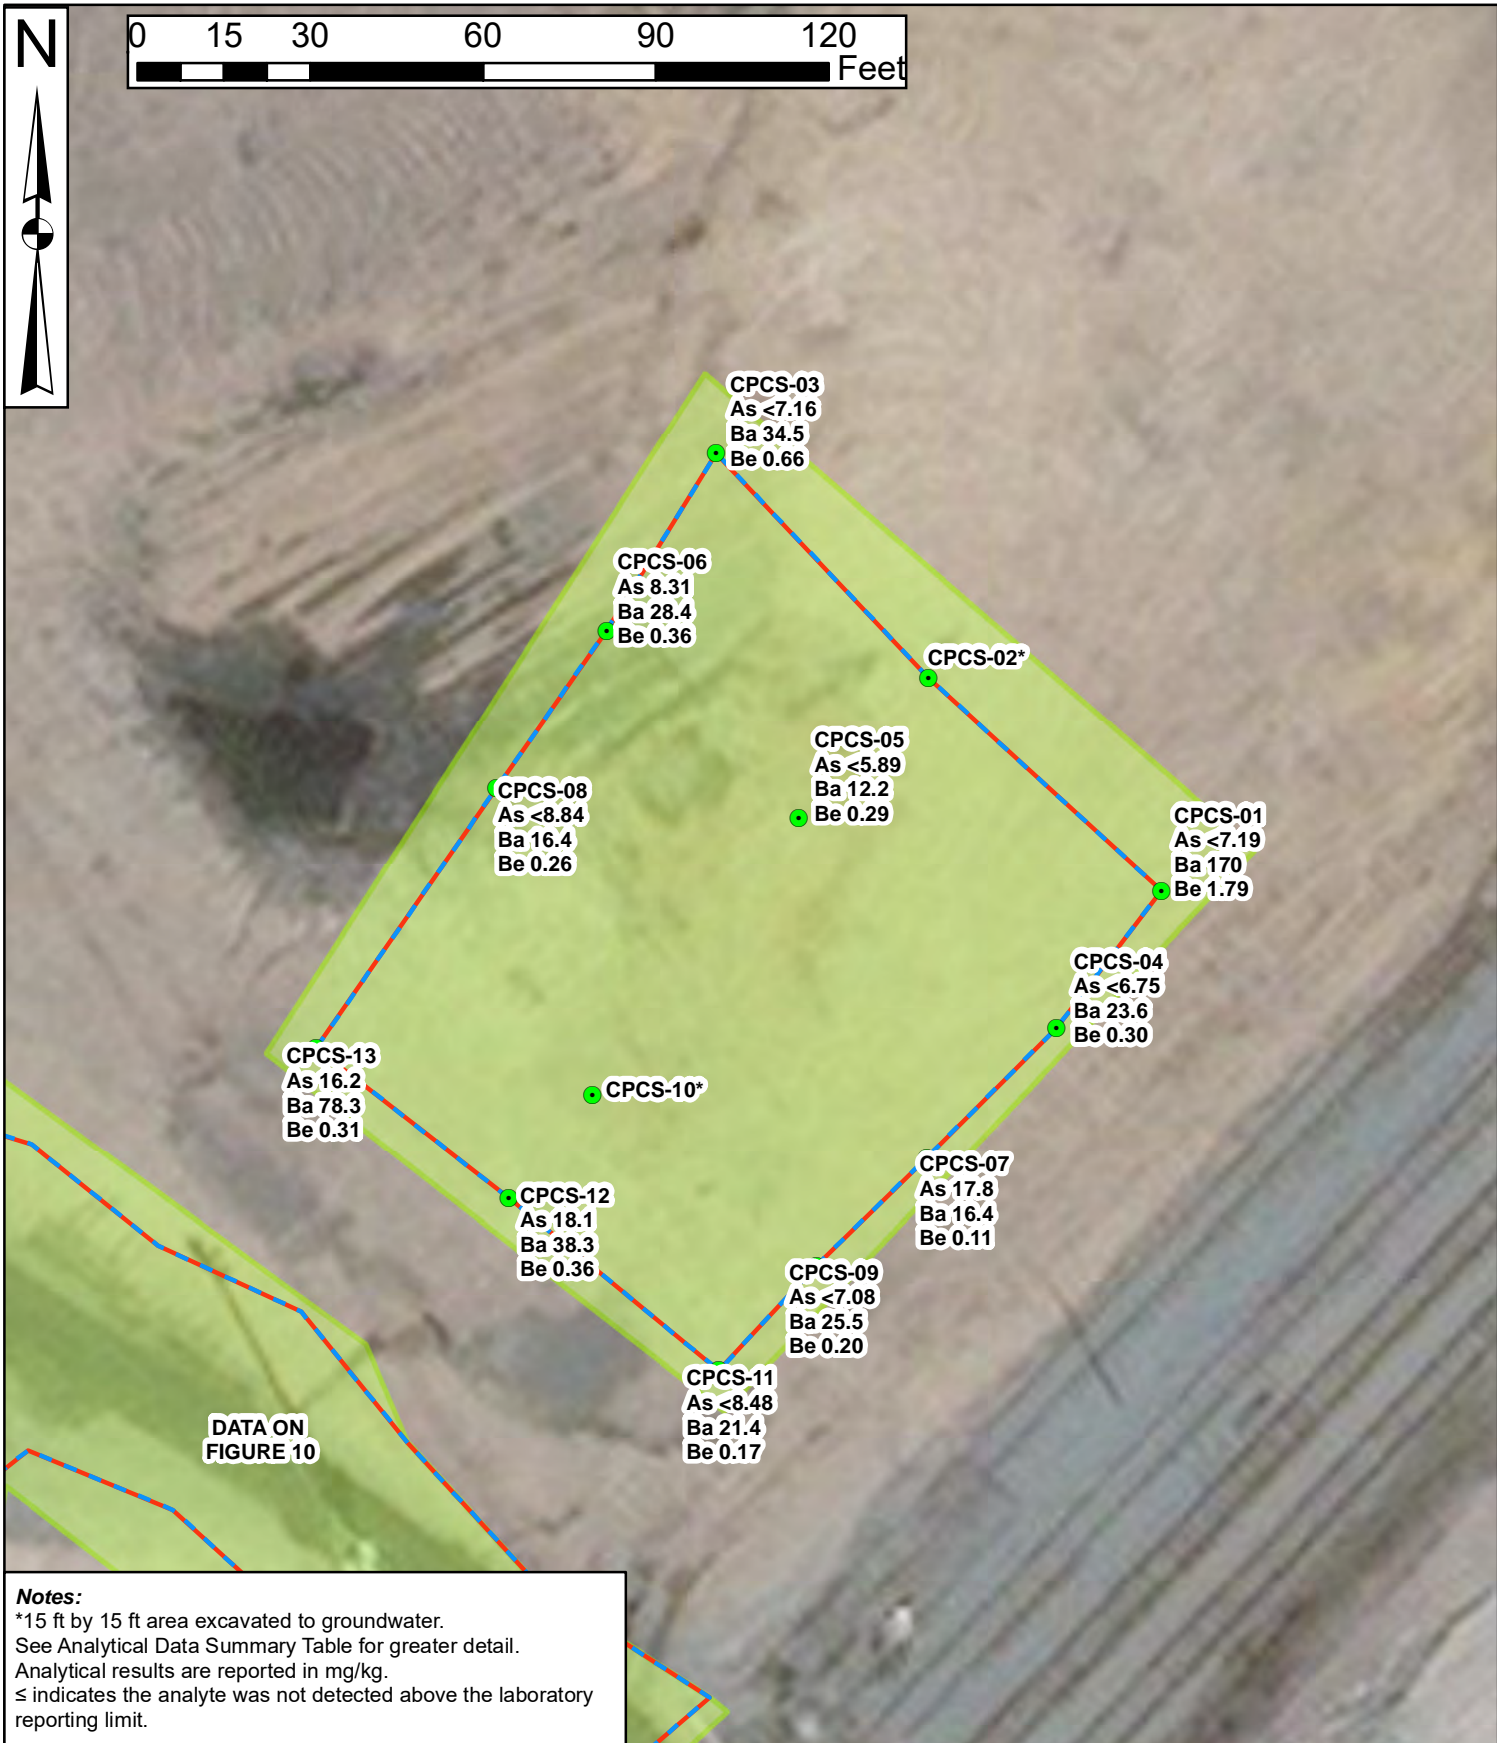
Type Type 1 RRS Type 3 RRS Excavated Areas			Plant Kraft Excavation Confirmation Sample Results Coal Pile Area Port Wentworth, GA	Figure 13
	Woodstock, GA	December 2018

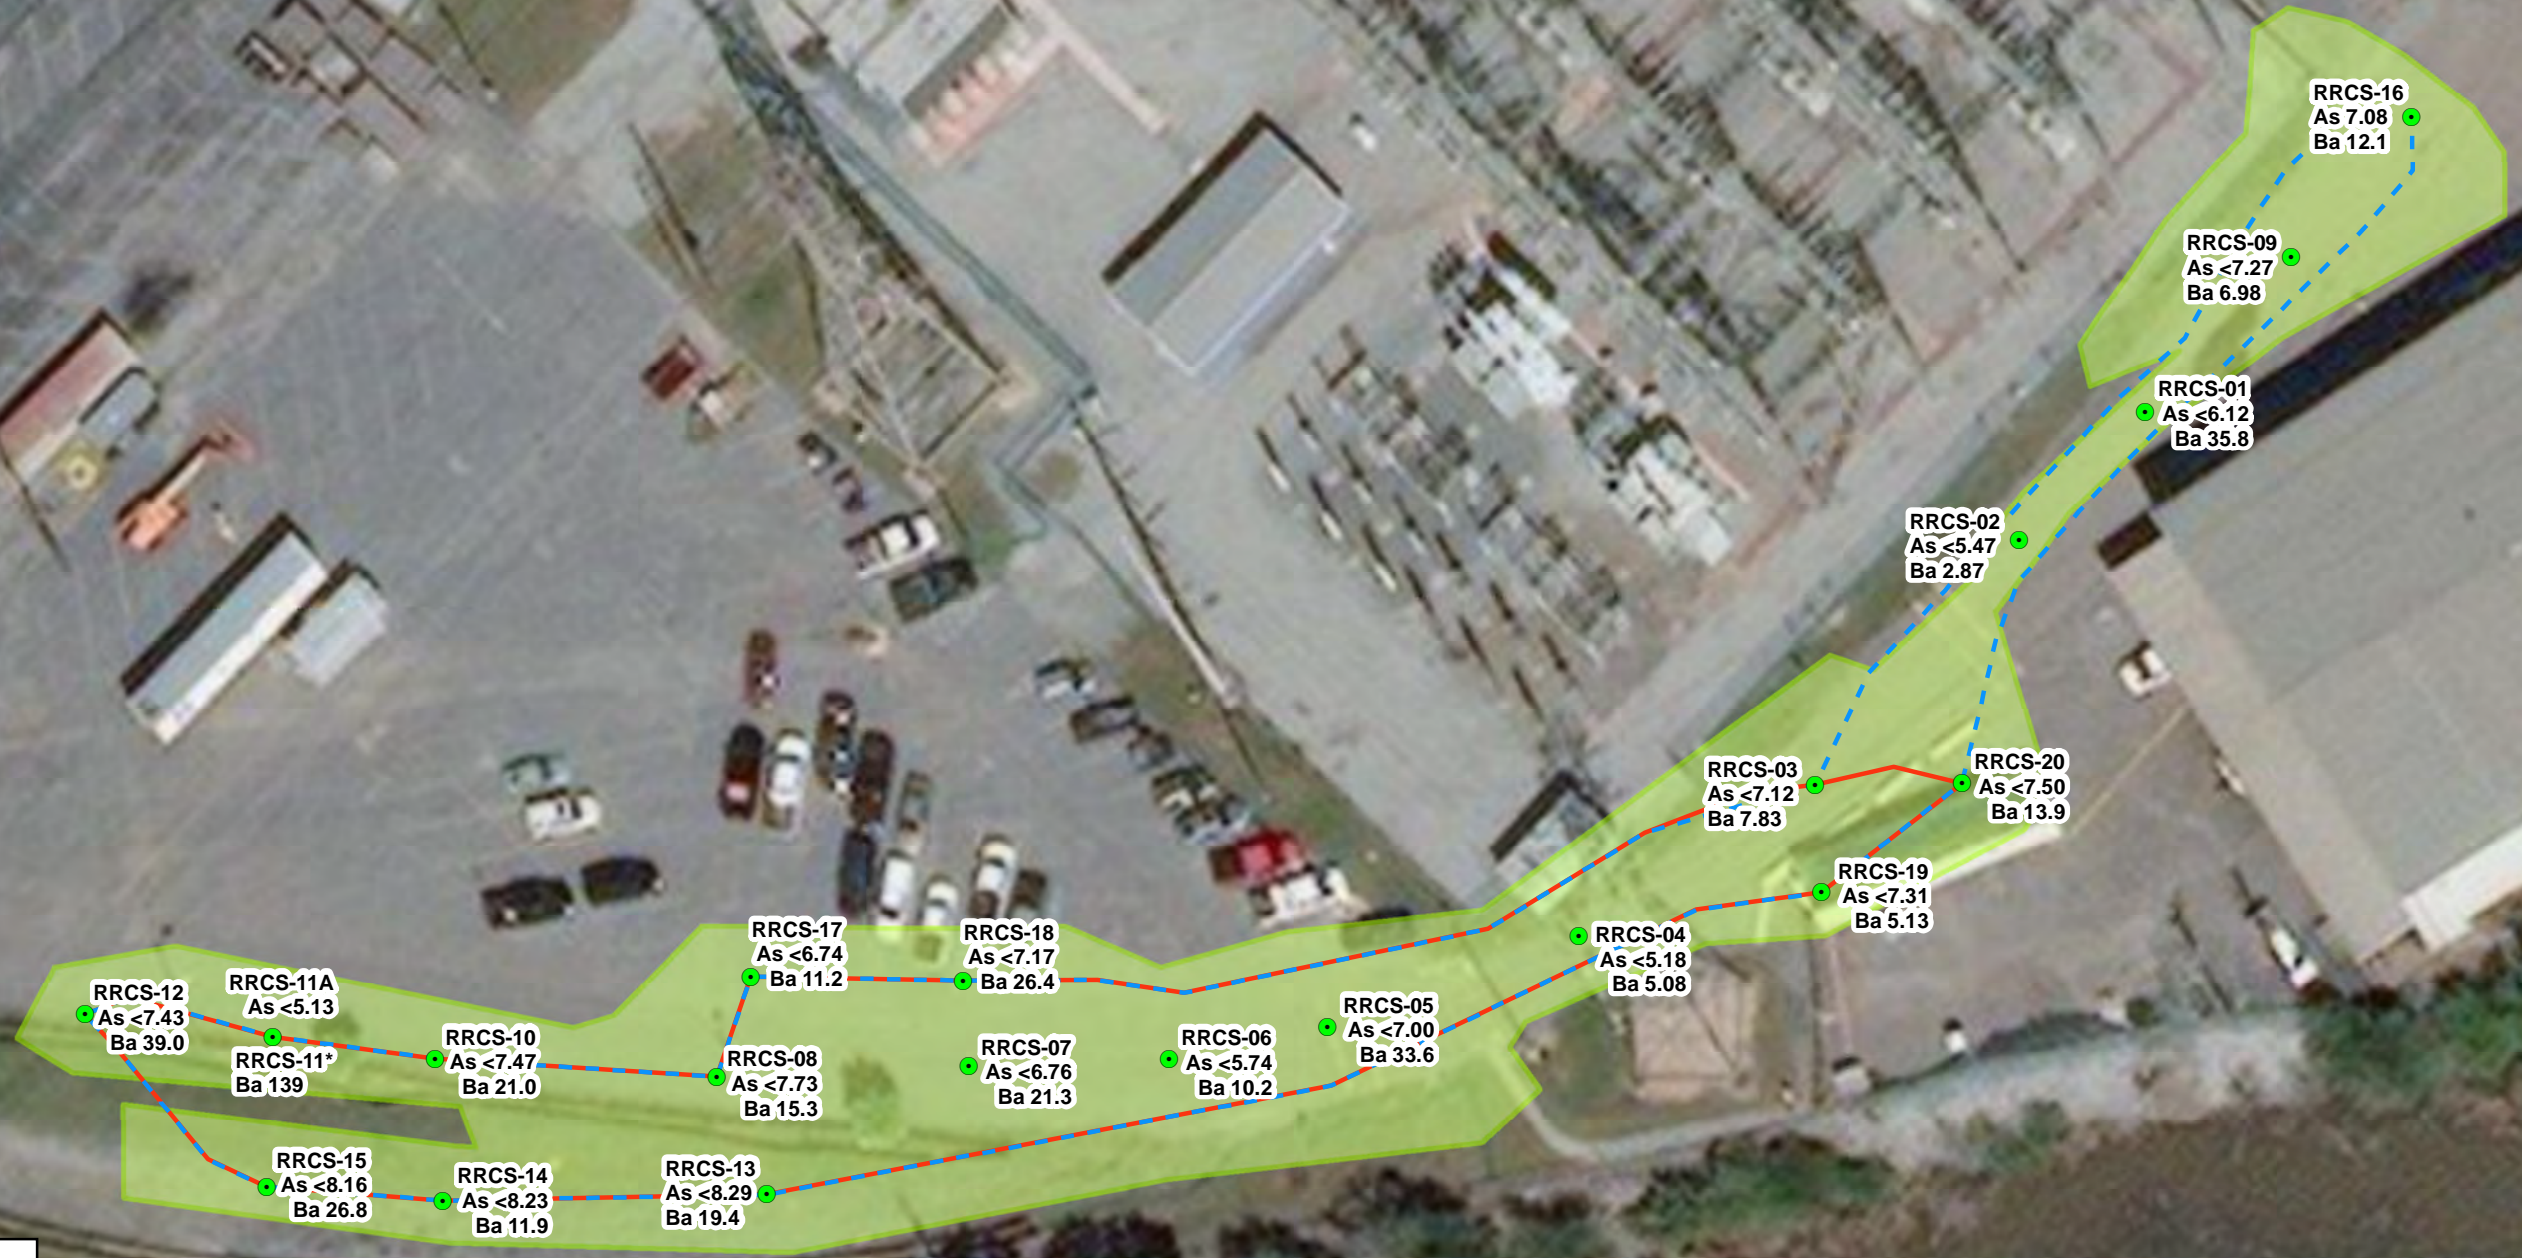
Plant Kraft Excavation Confirmation Sample Results Railroad Area	Figure 15
Woodstock, GA	December 2018	Port Wentworth, GA

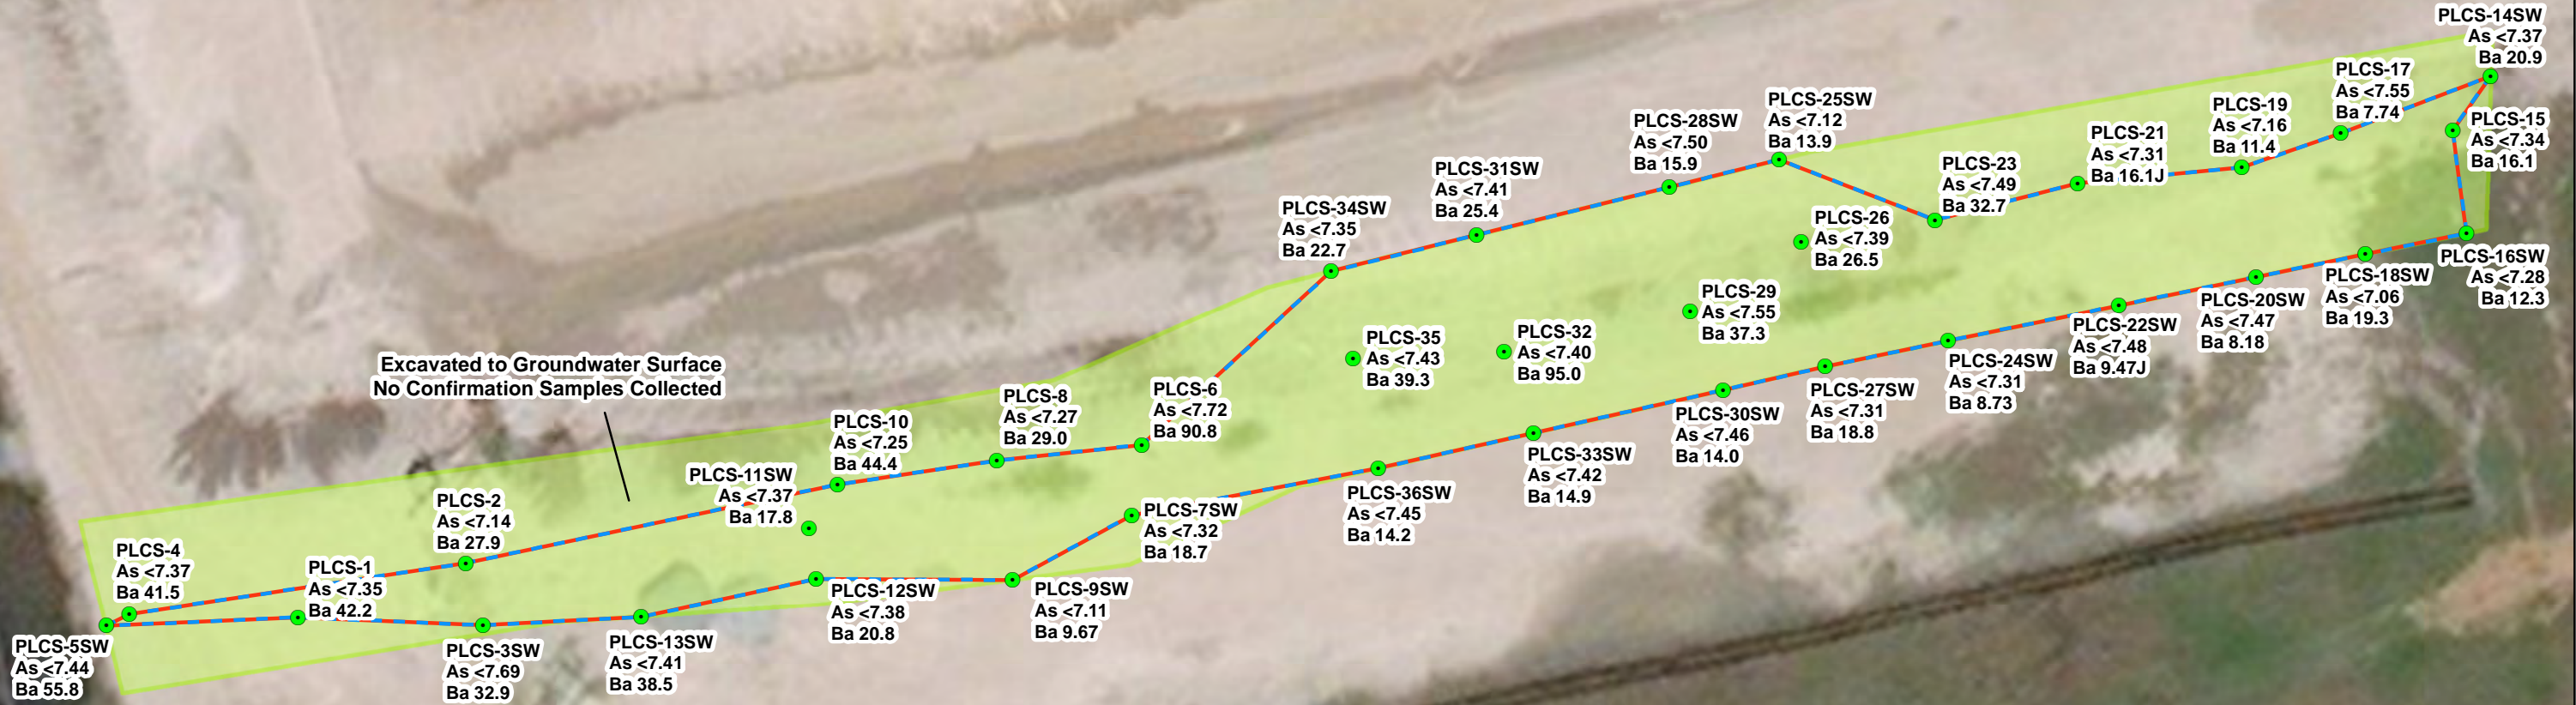
Excavated to Groundwater Surface
No Confirmation Samples Collected

Resolute <small>Environmental & Water Resources Consulting</small>		Plant Kraft Excavation Confirmation Sample Results Parking Lot Area	Figure 17
Woodstock, GA	December 2018	Port Wentworth, GA

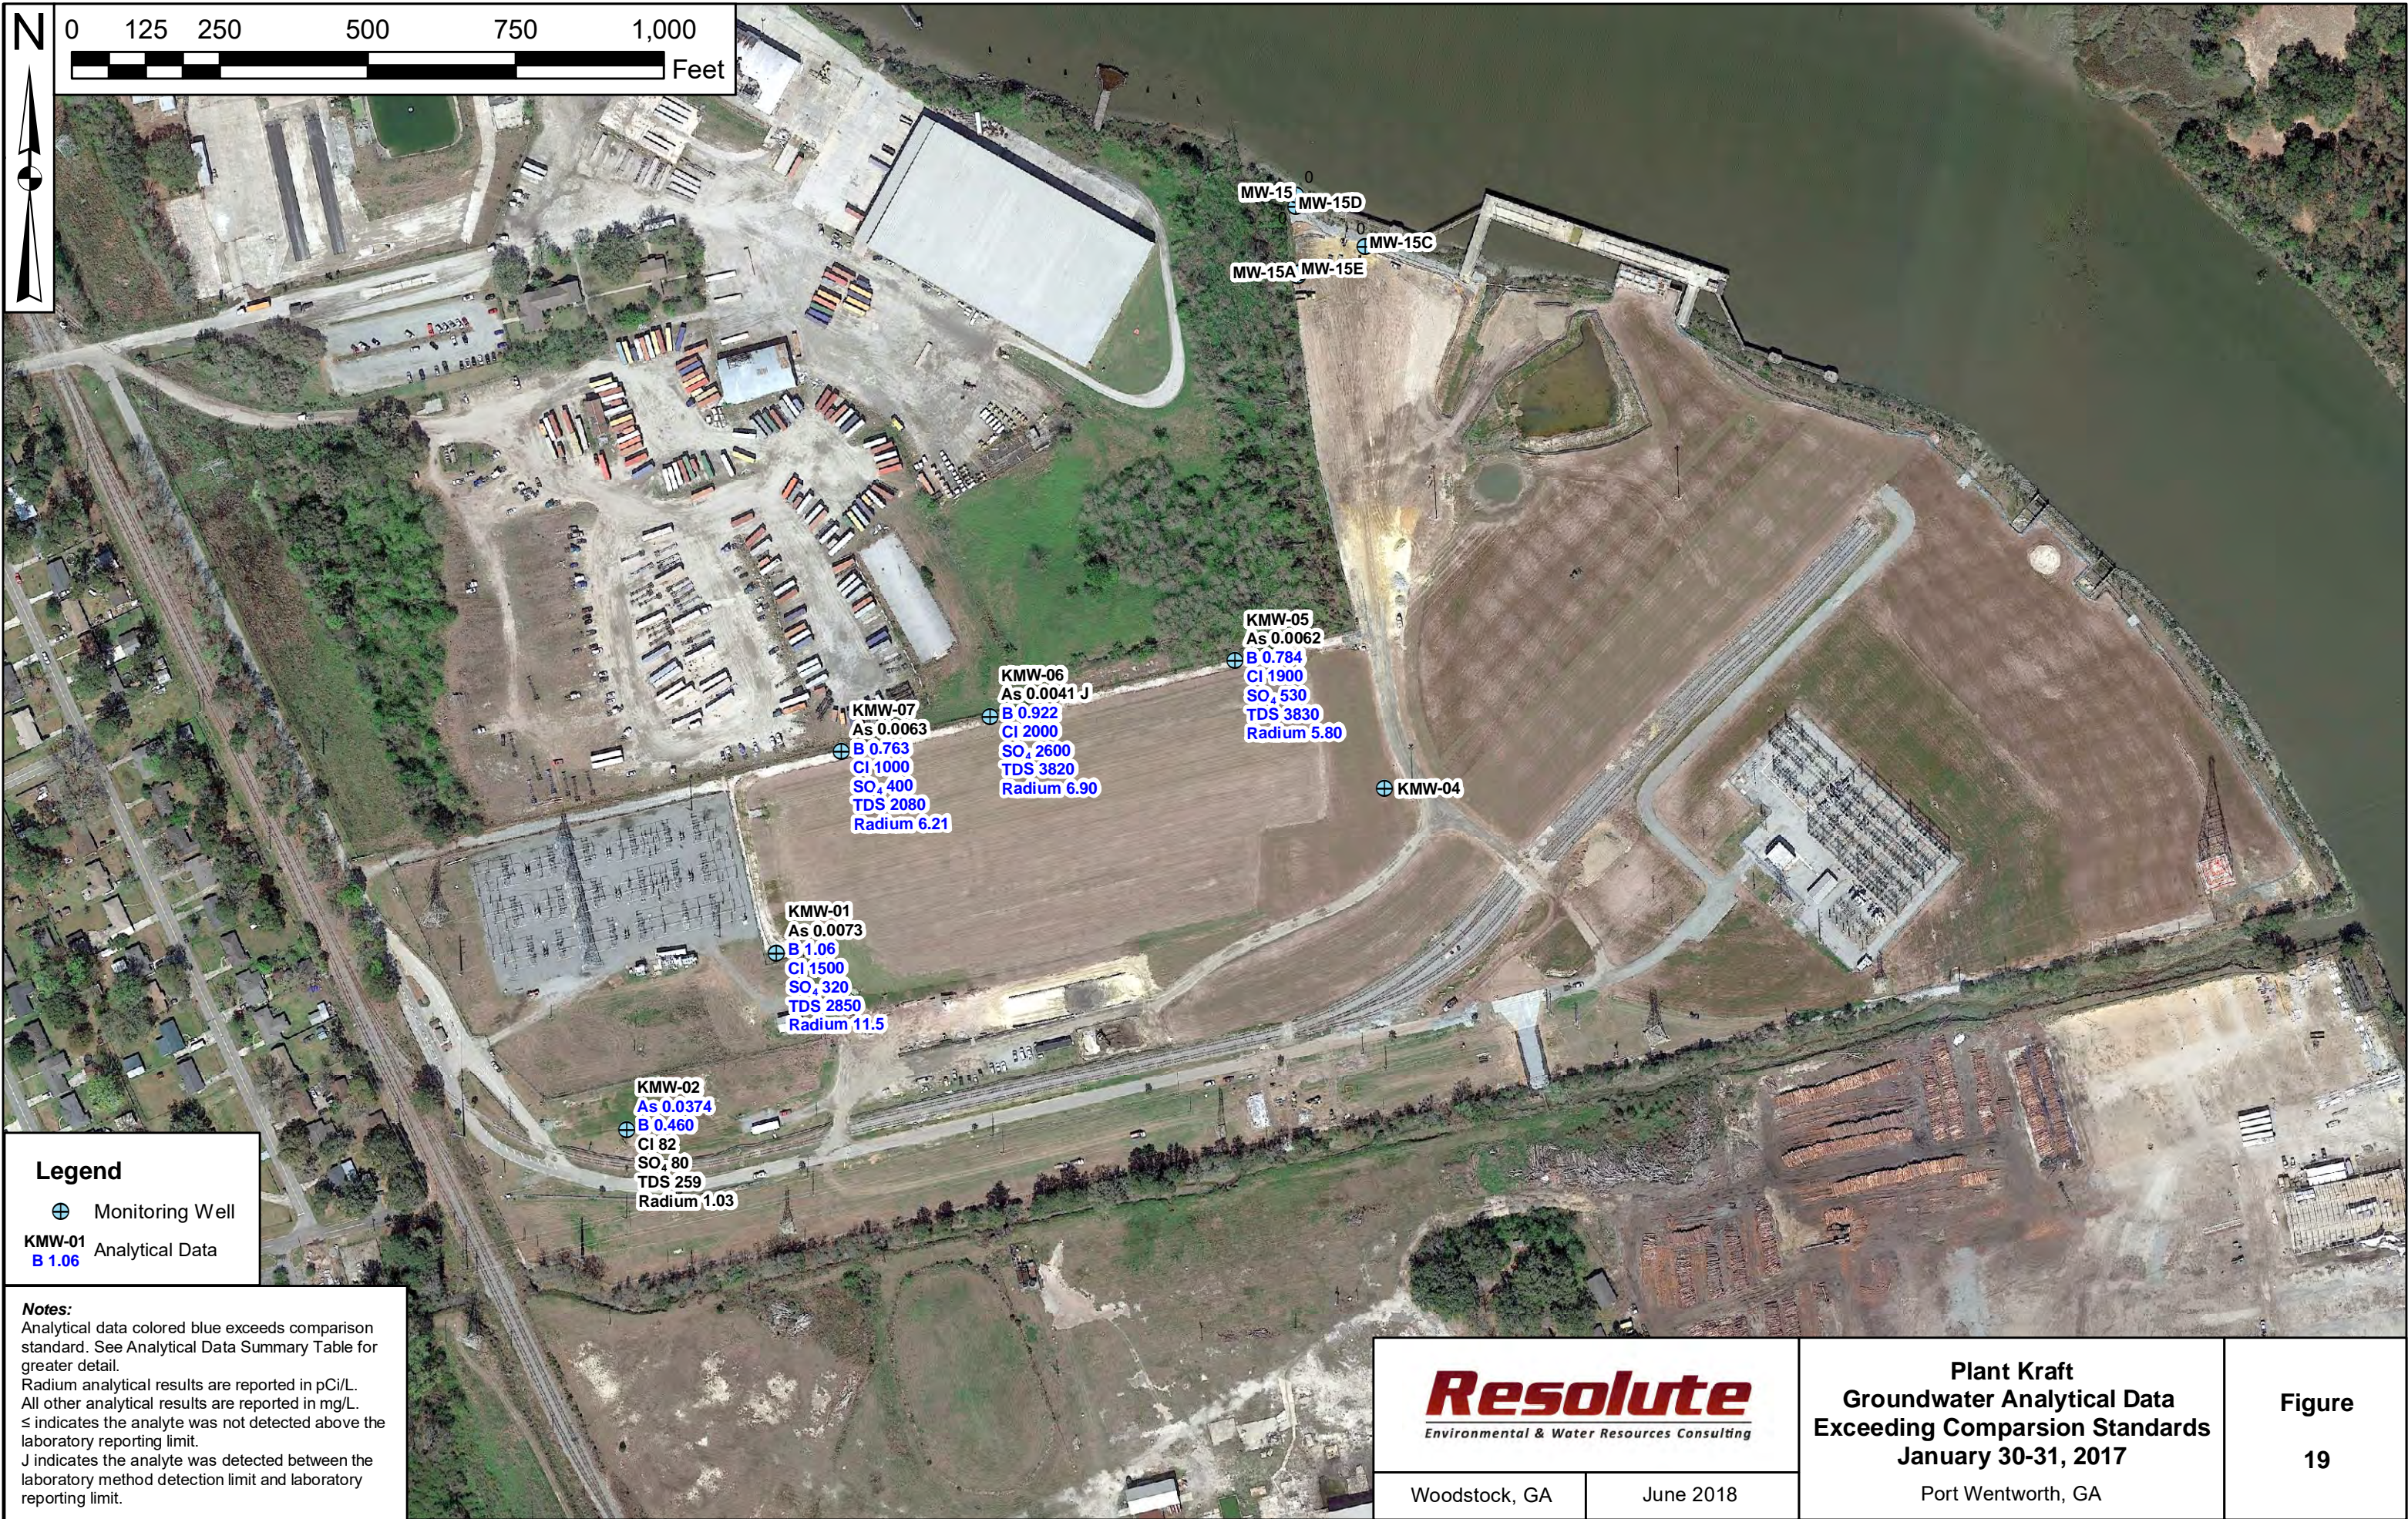
Plant Kraft Groundwater Analytical Data Exceeding Comparison Standards January 30-31, 2017		Figure 19
		Woodstock, GA	June 2018

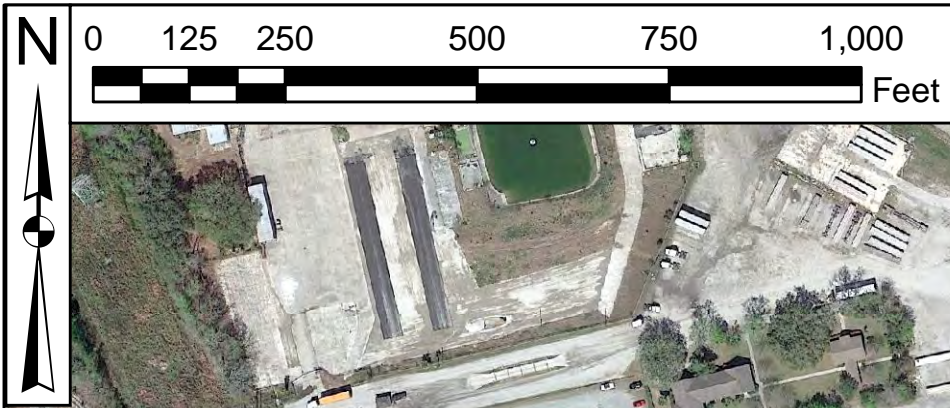
Notes:
 Analytical data colored blue exceeds comparison standard. See Analytical Data Summary Table for greater detail.
 Radium analytical results are reported in pCi/L.
 All other analytical results are reported in mg/L.
 ≤ indicates the analyte was not detected above the laboratory reporting limit.
 J indicates the analyte was detected between the laboratory method detection limit and laboratory reporting limit.

Based on the change in groundwater flow directions between the 2016/January 2017 potentiometric surface maps (Figures 27 through 29), and the August 2017 and February 2018 potentiometric surface maps (Figures 30 and 31), the arsenic concentrations detected in well KMW-02 appear to have increased before the change in groundwater flow from the north in the August 2017 potentiometric surface map. The extent of arsenic exceeding the Type 1/3 RRS has been delineated by monitoring wells KMW-04 to the east (hydraulically side-gradient), KMW-09 to the west (hydraulically side-gradient), KMW-08 to the north (hydraulically up-gradient), and KMW-10 through KMW-12 to the south (hydraulically downgradient). Analytical results of metals from monitoring wells around the former ash pond area are presented in Table 4, and Figures 19 through 21a.

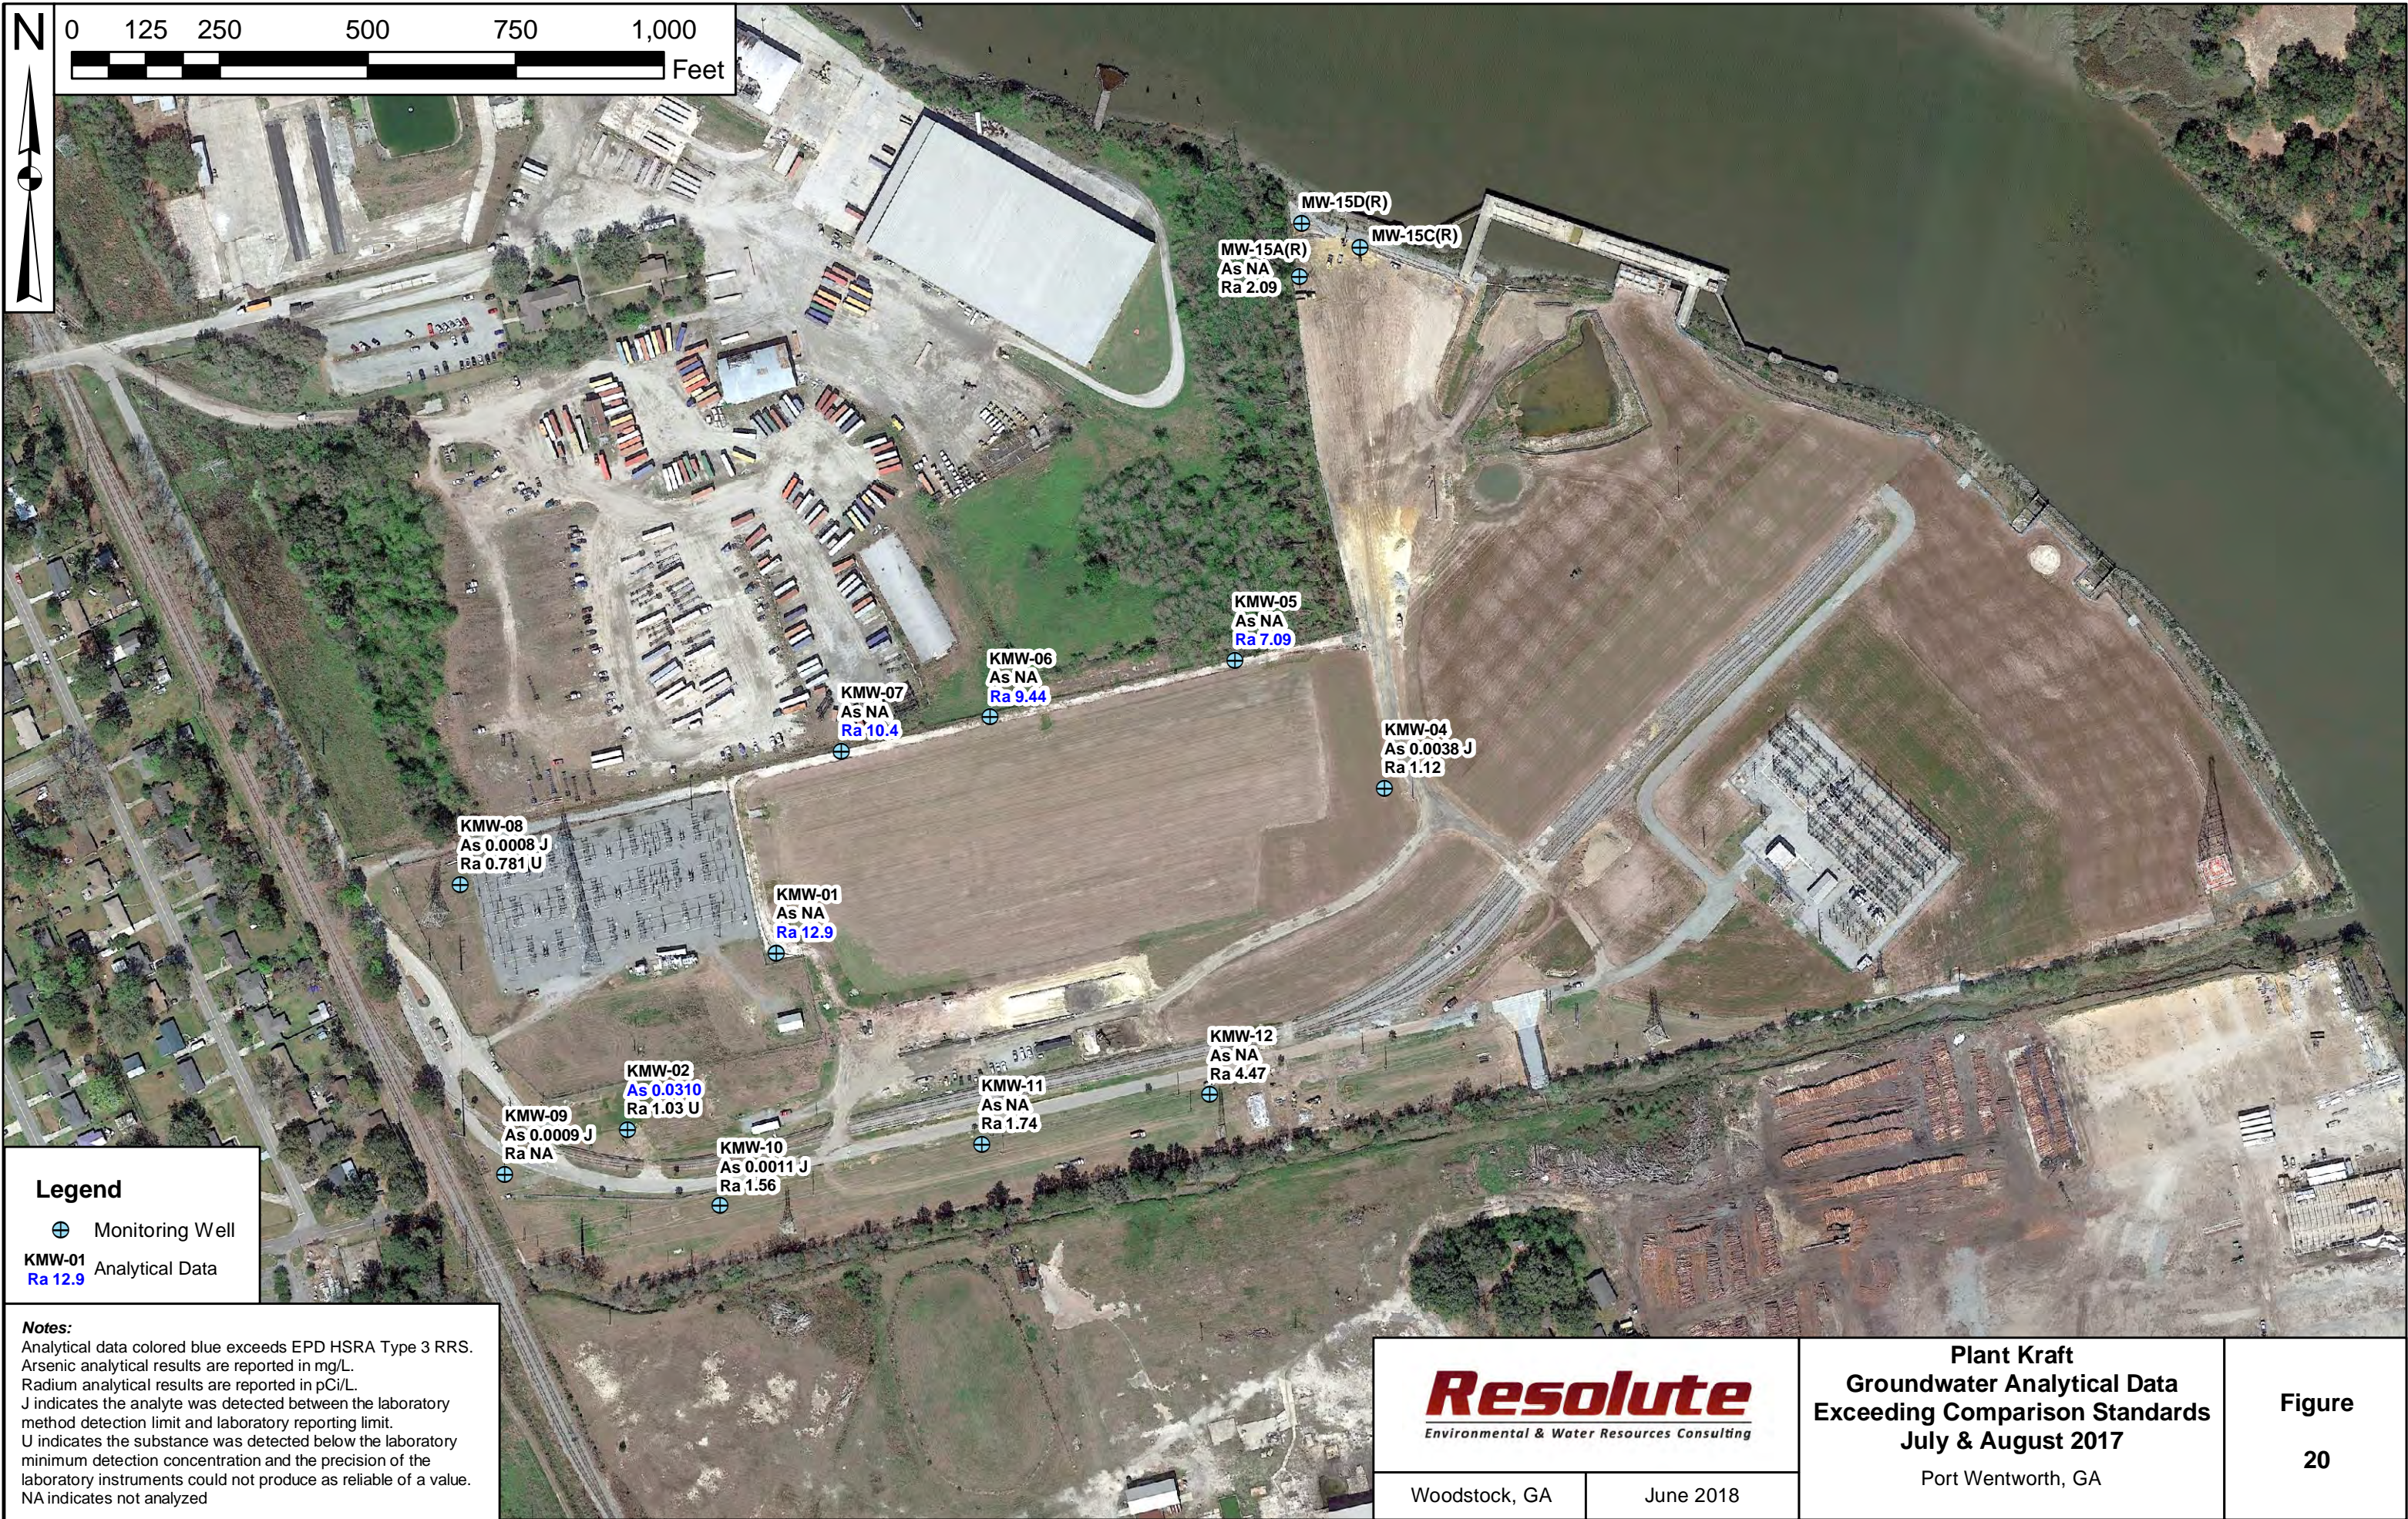
Plant Kraft Groundwater Analytical Data Exceeding Comparison Standards July & August 2017		Figure 20
	Woodstock, GA	June 2018

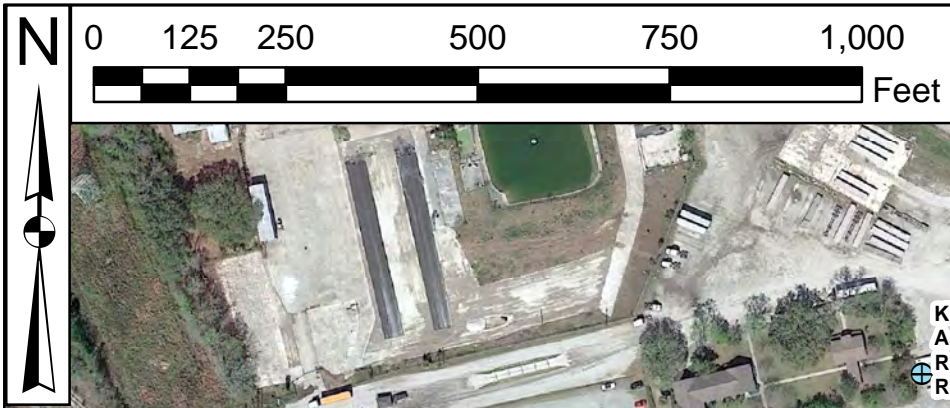
Notes:
 Analytical data colored blue exceeds EPD HSRA Type 3 RRS.
 Arsenic analytical results are reported in mg/L.
 Radium analytical results are reported in pCi/L.
 J indicates the analyte was detected between the laboratory method detection limit and laboratory reporting limit.
 U indicates the substance was detected below the laboratory minimum detection concentration and the precision of the laboratory instruments could not produce as reliable of a value.
 NA indicates not analyzed

In July 2017, five (5) monitoring wells (KMW-08 through KMW-12), were installed to further assess the vertical and horizontal extent of arsenic and radium in groundwater at the site. In January 2018, two (2) additional monitoring wells (KMW-03 and KMW-13) were installed to the north of the former ash pond, on the GPA property. KMW-01 and KMW-12 were resampled for radium in May 2018, with results shown on Figure 21a. In October 2018, an additional groundwater monitoring event was conducted utilizing the KMW series wells, around the former ash pond, to evaluate radium concentrations. Groundwater sampling results from the January 2017, July and August 2017, February 2018, and October 2018 sampling events are shown on Figures 19 through 22.

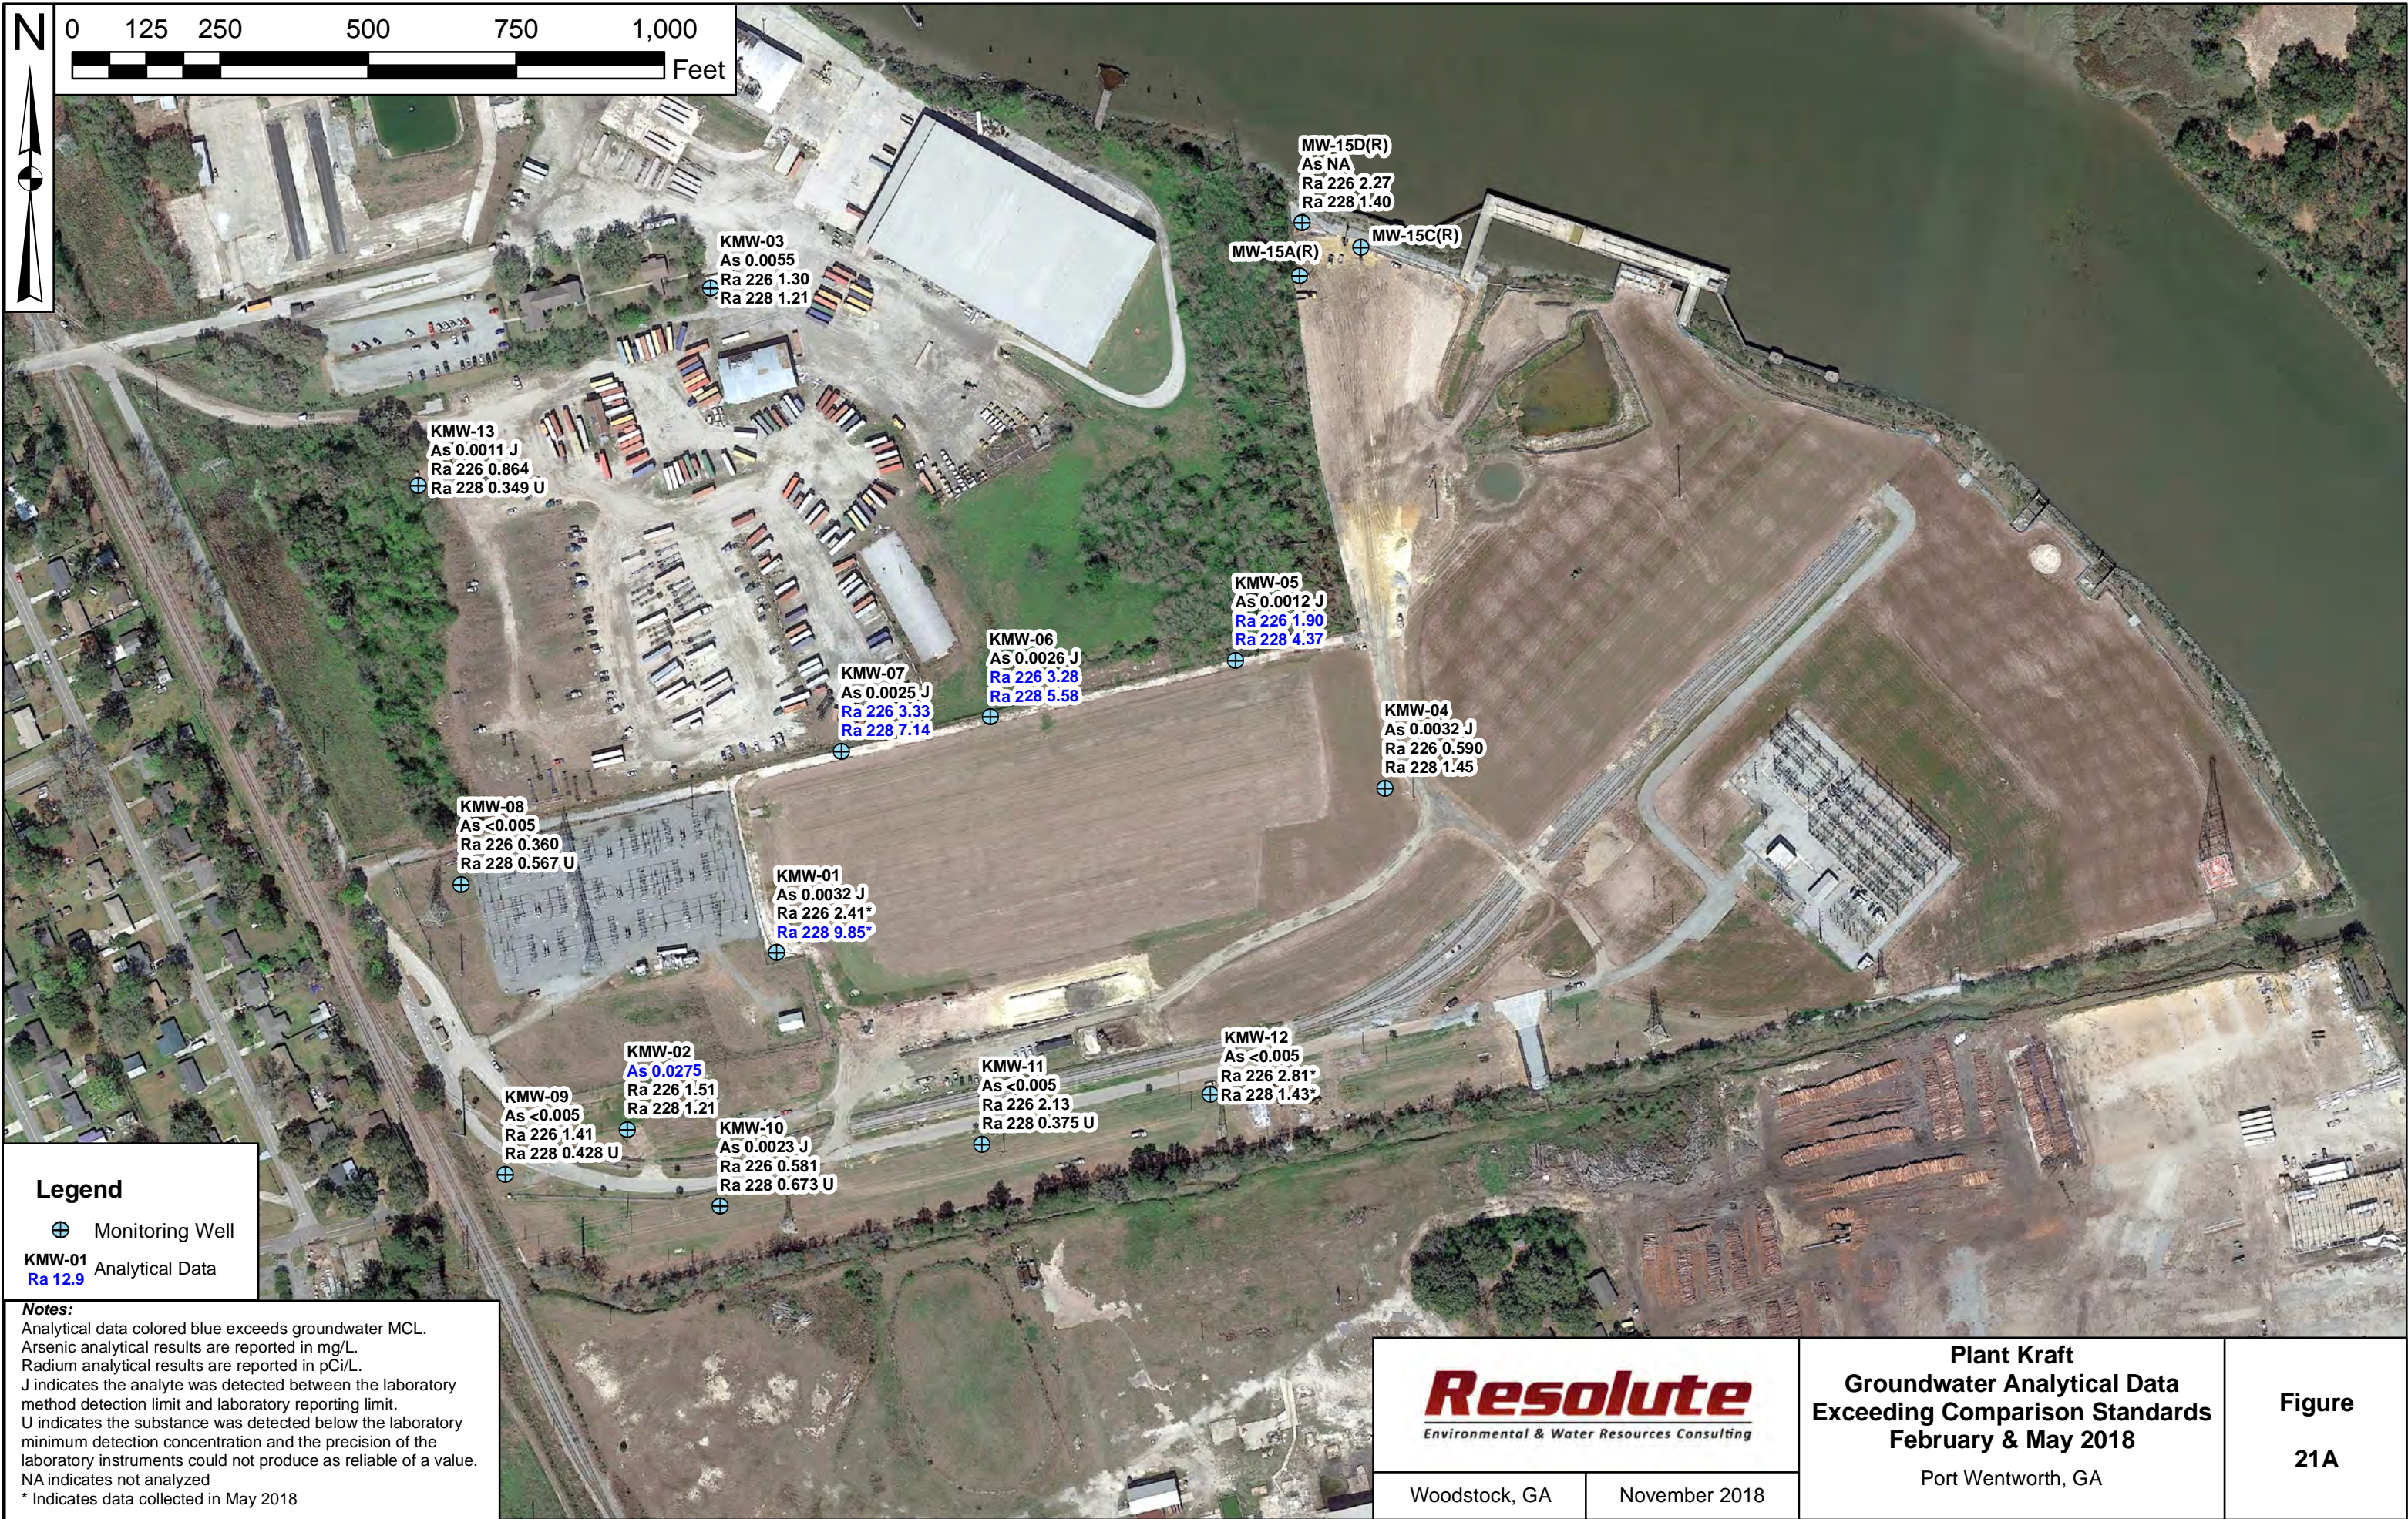
Figure
 21A

Plant Kraft
 Groundwater Analytical Data
 Exceeding Comparison Standards
 February & May 2018
 Port Wentworth, GA
