Name of Document: VRP Revised Compliance Status Report

Site Name: Georgia Power Plant Kraft

Subject: Response to EPD Comments
Voluntary Remediation Program Compliance Status Report
Savannah Electric - Plant Kraft, HSI Site No. 10415
155 Crossgate Road, Port Wentworth, Chatham County, Georgia

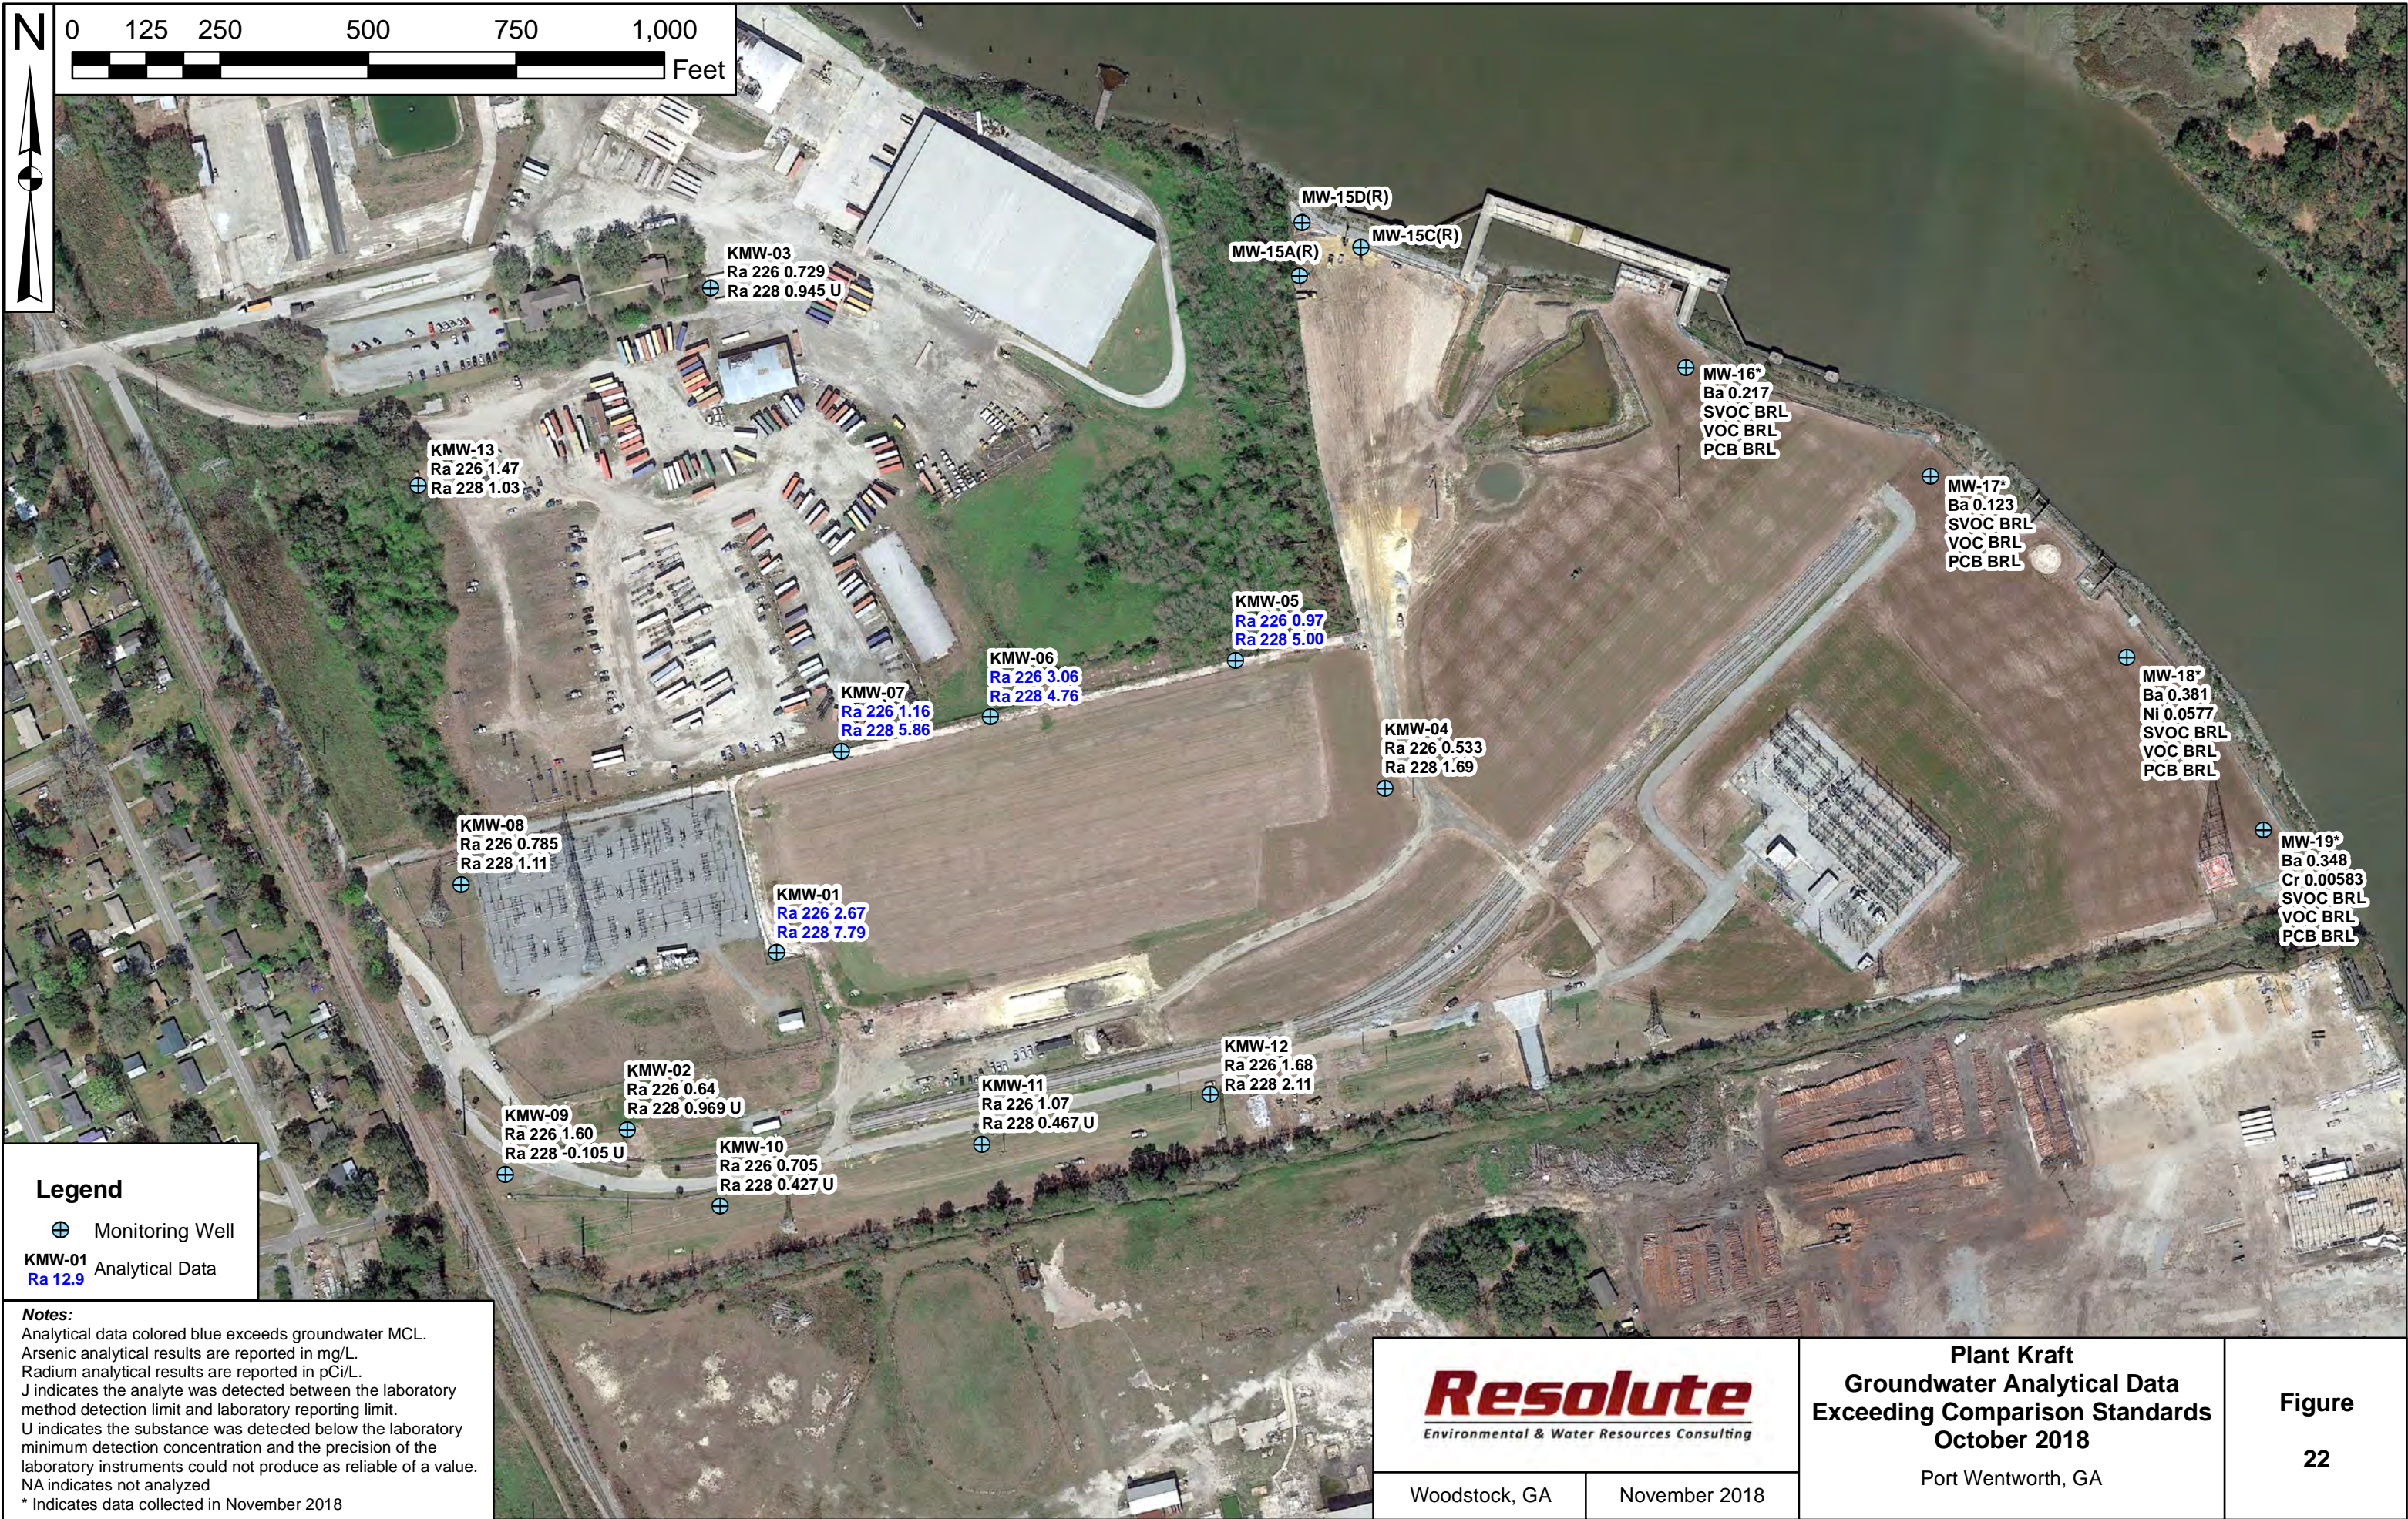
Figure
 22

An additional groundwater monitoring event was performed, and the results are presented in Section 3.4.1.3 on page 24. The results are summarized on Table 5 and shown on Figure 22.

Additional groundwater sampling for VOCs and PCBs was performed, as discussed in Section 3.1.2 on page 20. The results are presented in Section 3.4.2 on page 26. The results are summarized on Table 4A and shown on Figure 22.

Plant Kraft
 Groundwater Analytical Data
 Exceeding Comparison Standards
 October 2018
 Port Wentworth, GA

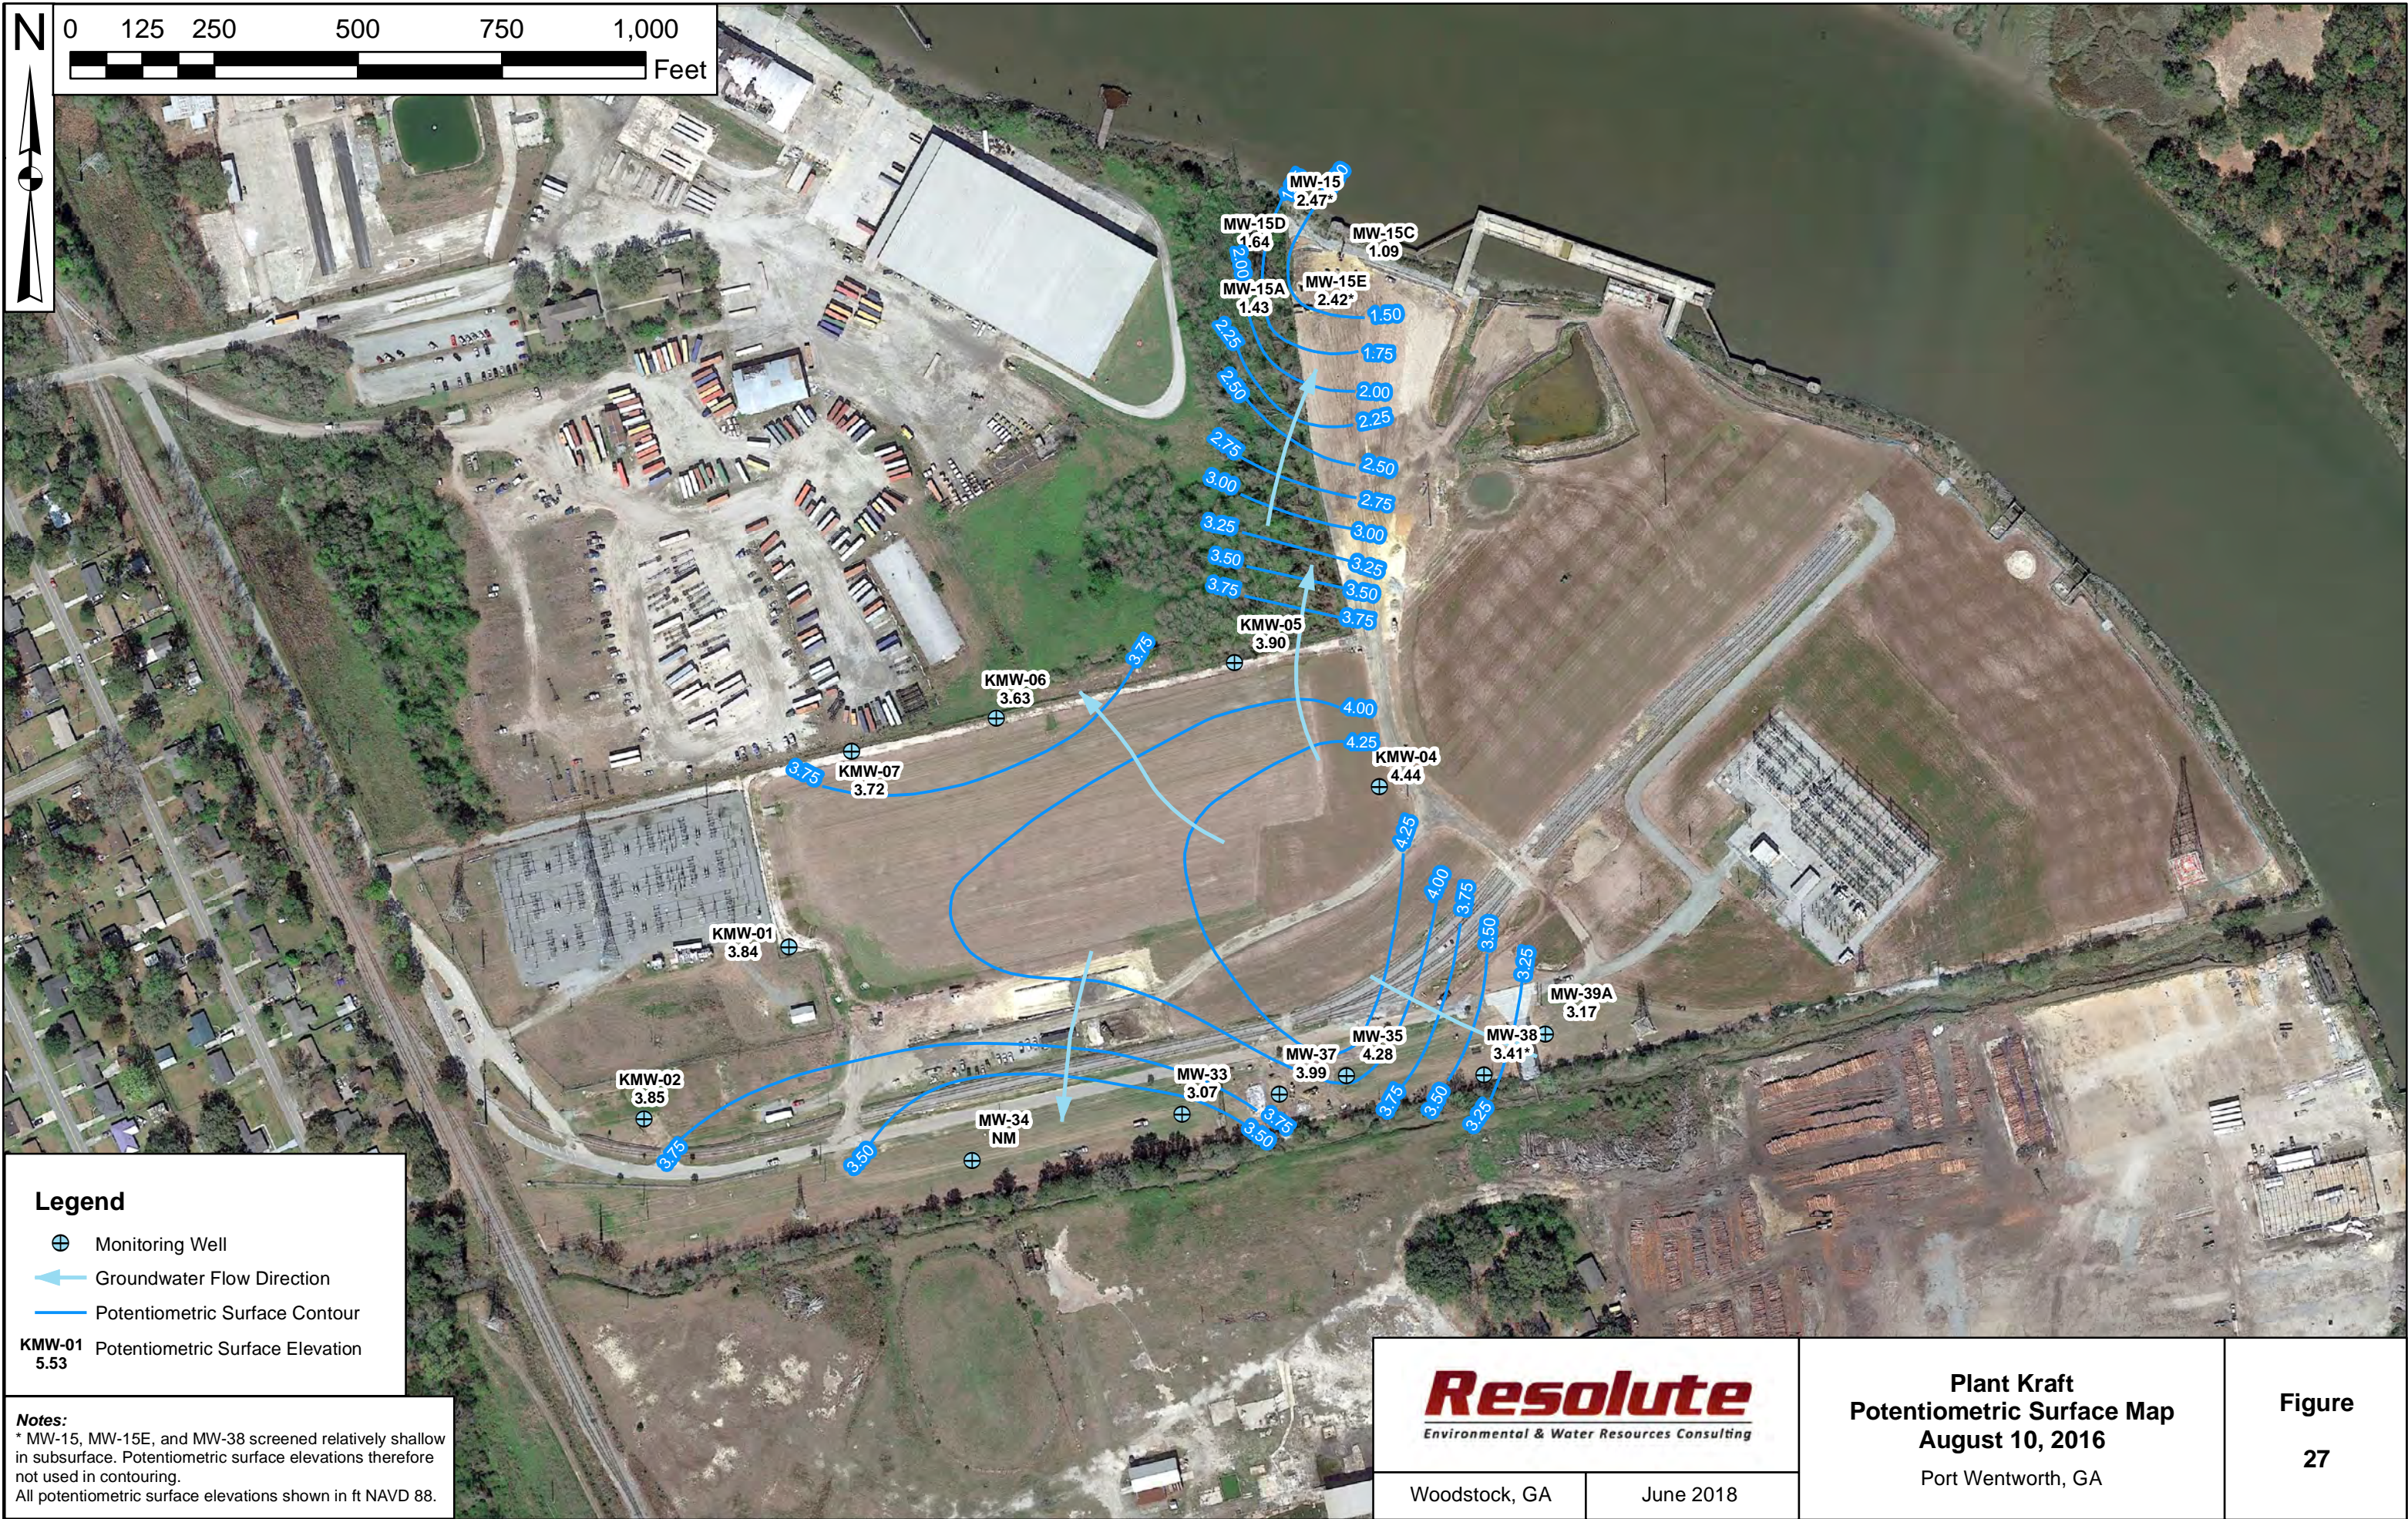
Figure
 27

Plant Kraft
Potentiometric Surface Map
 August 10, 2016
 Port Wentworth, GA

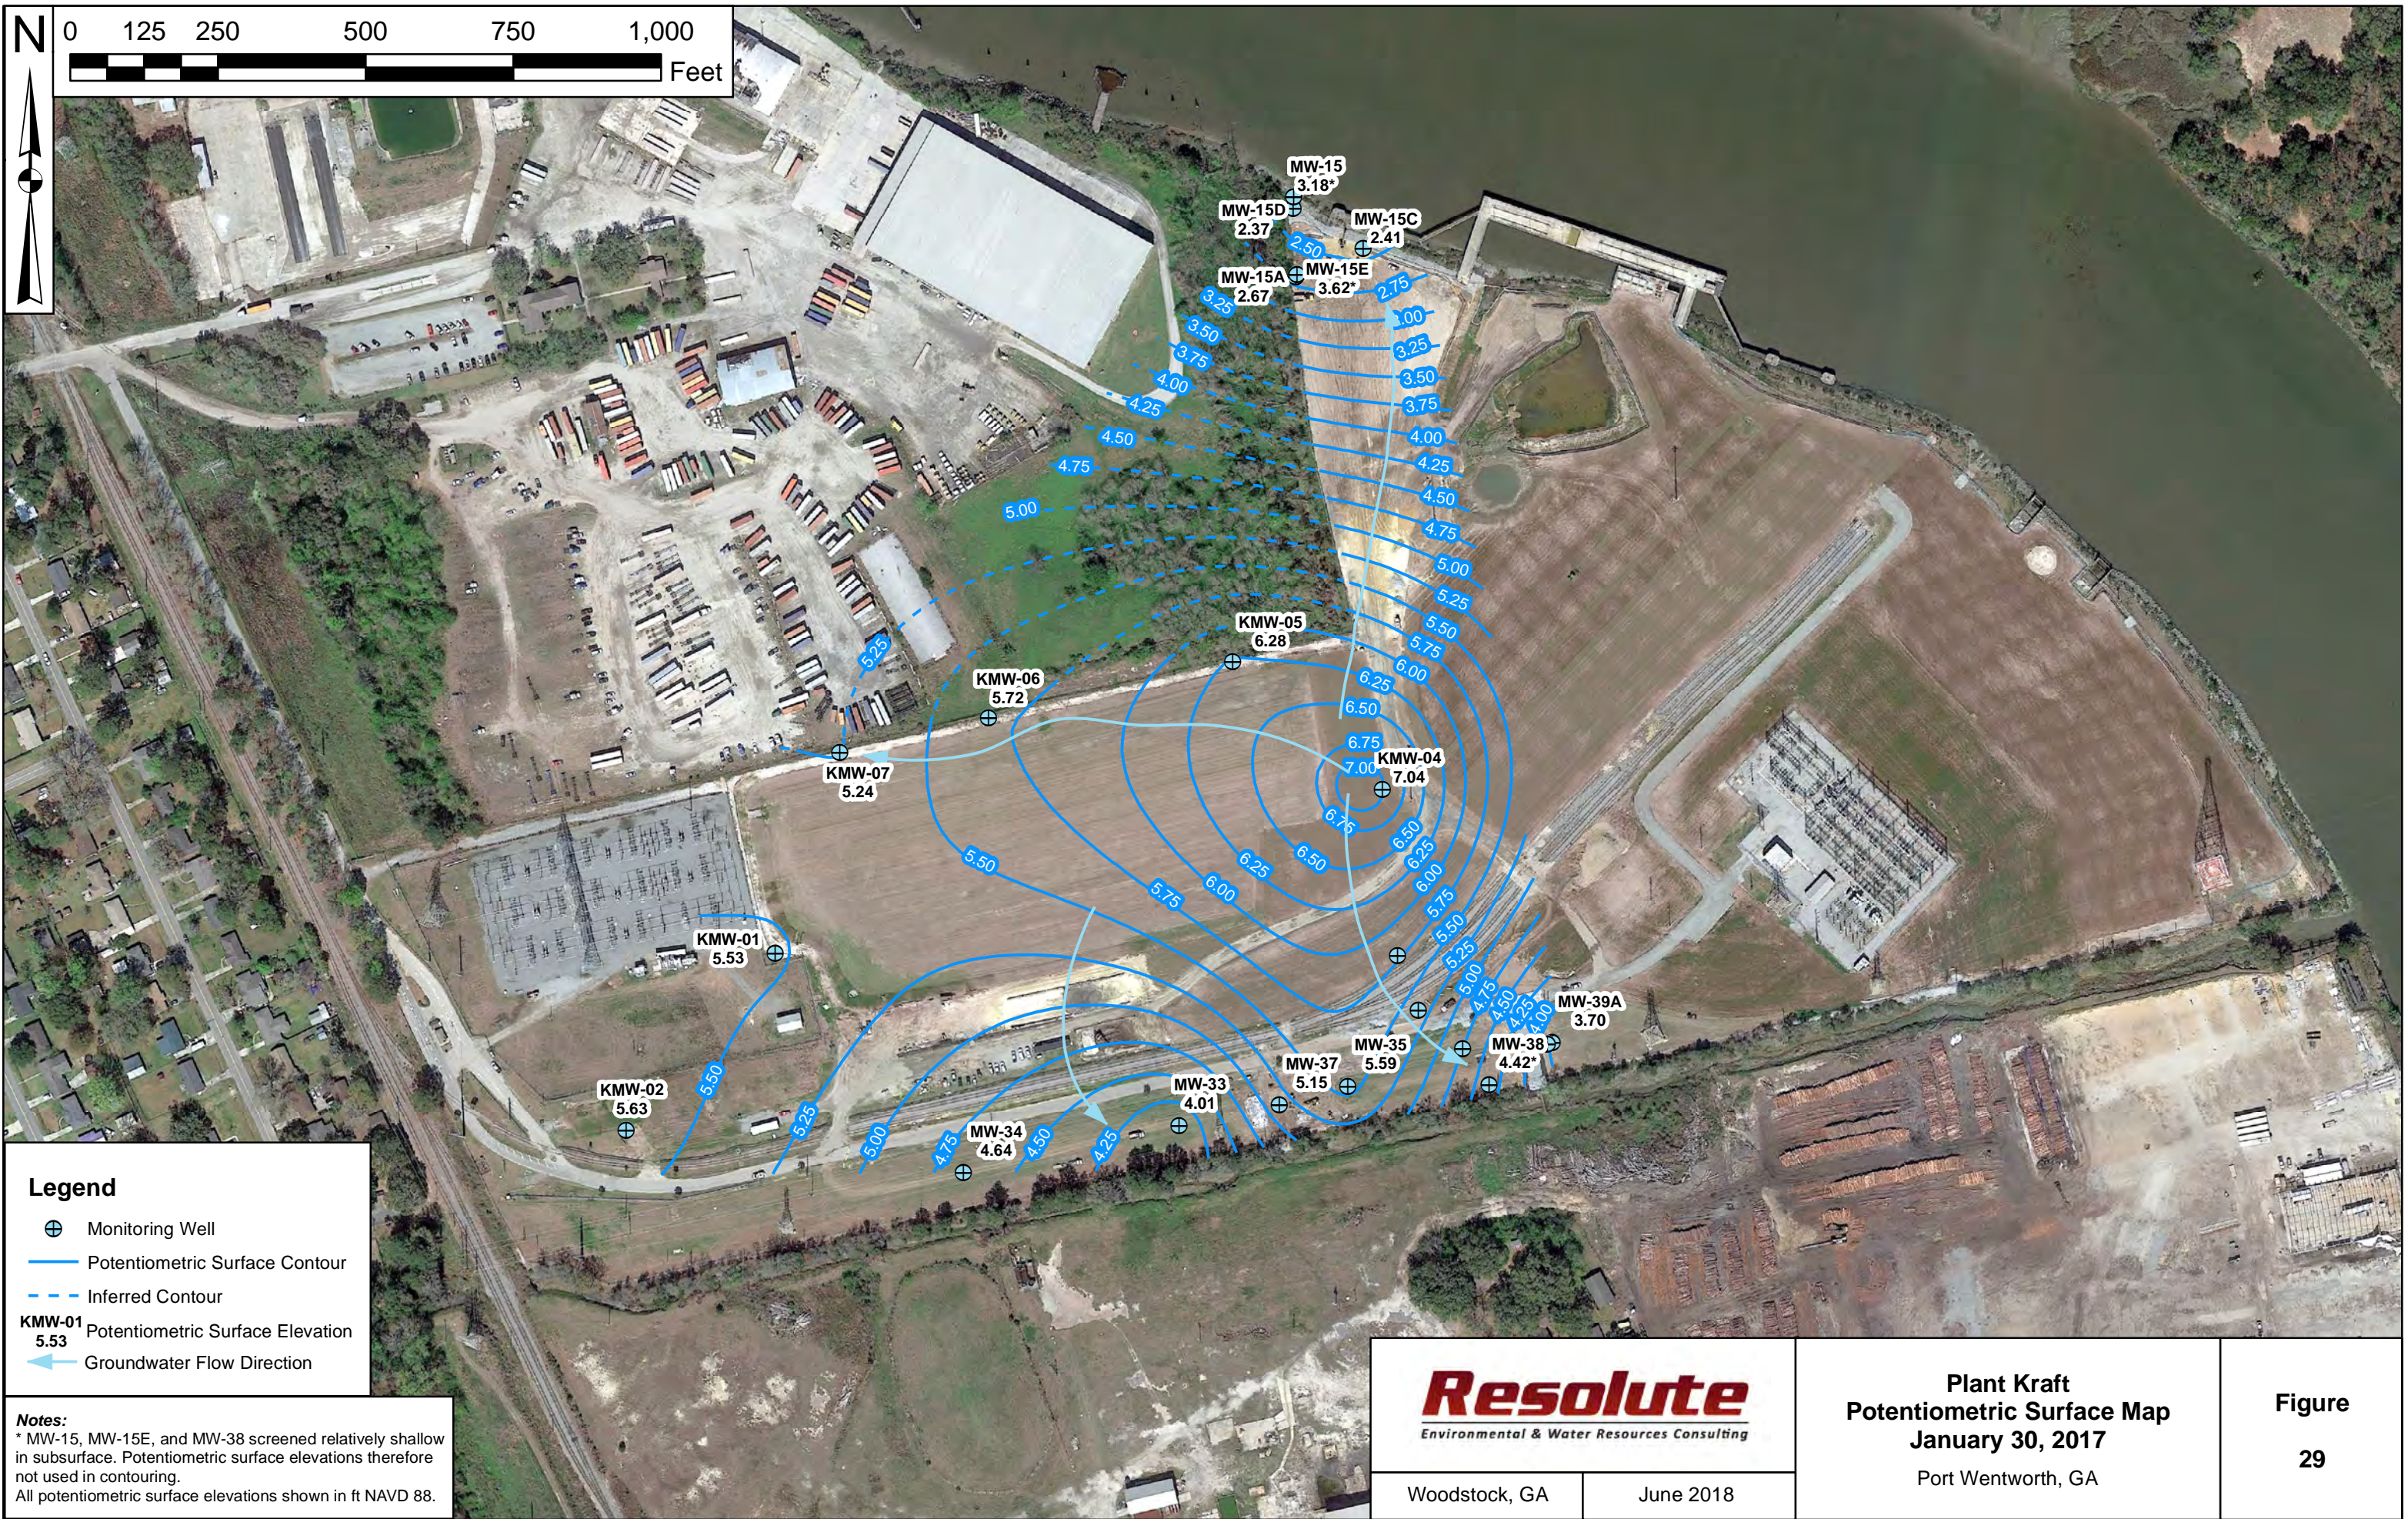
**Figure
 29**

**Plant Kraft
 Potentiometric Surface Map
 January 30, 2017
 Port Wentworth, GA**

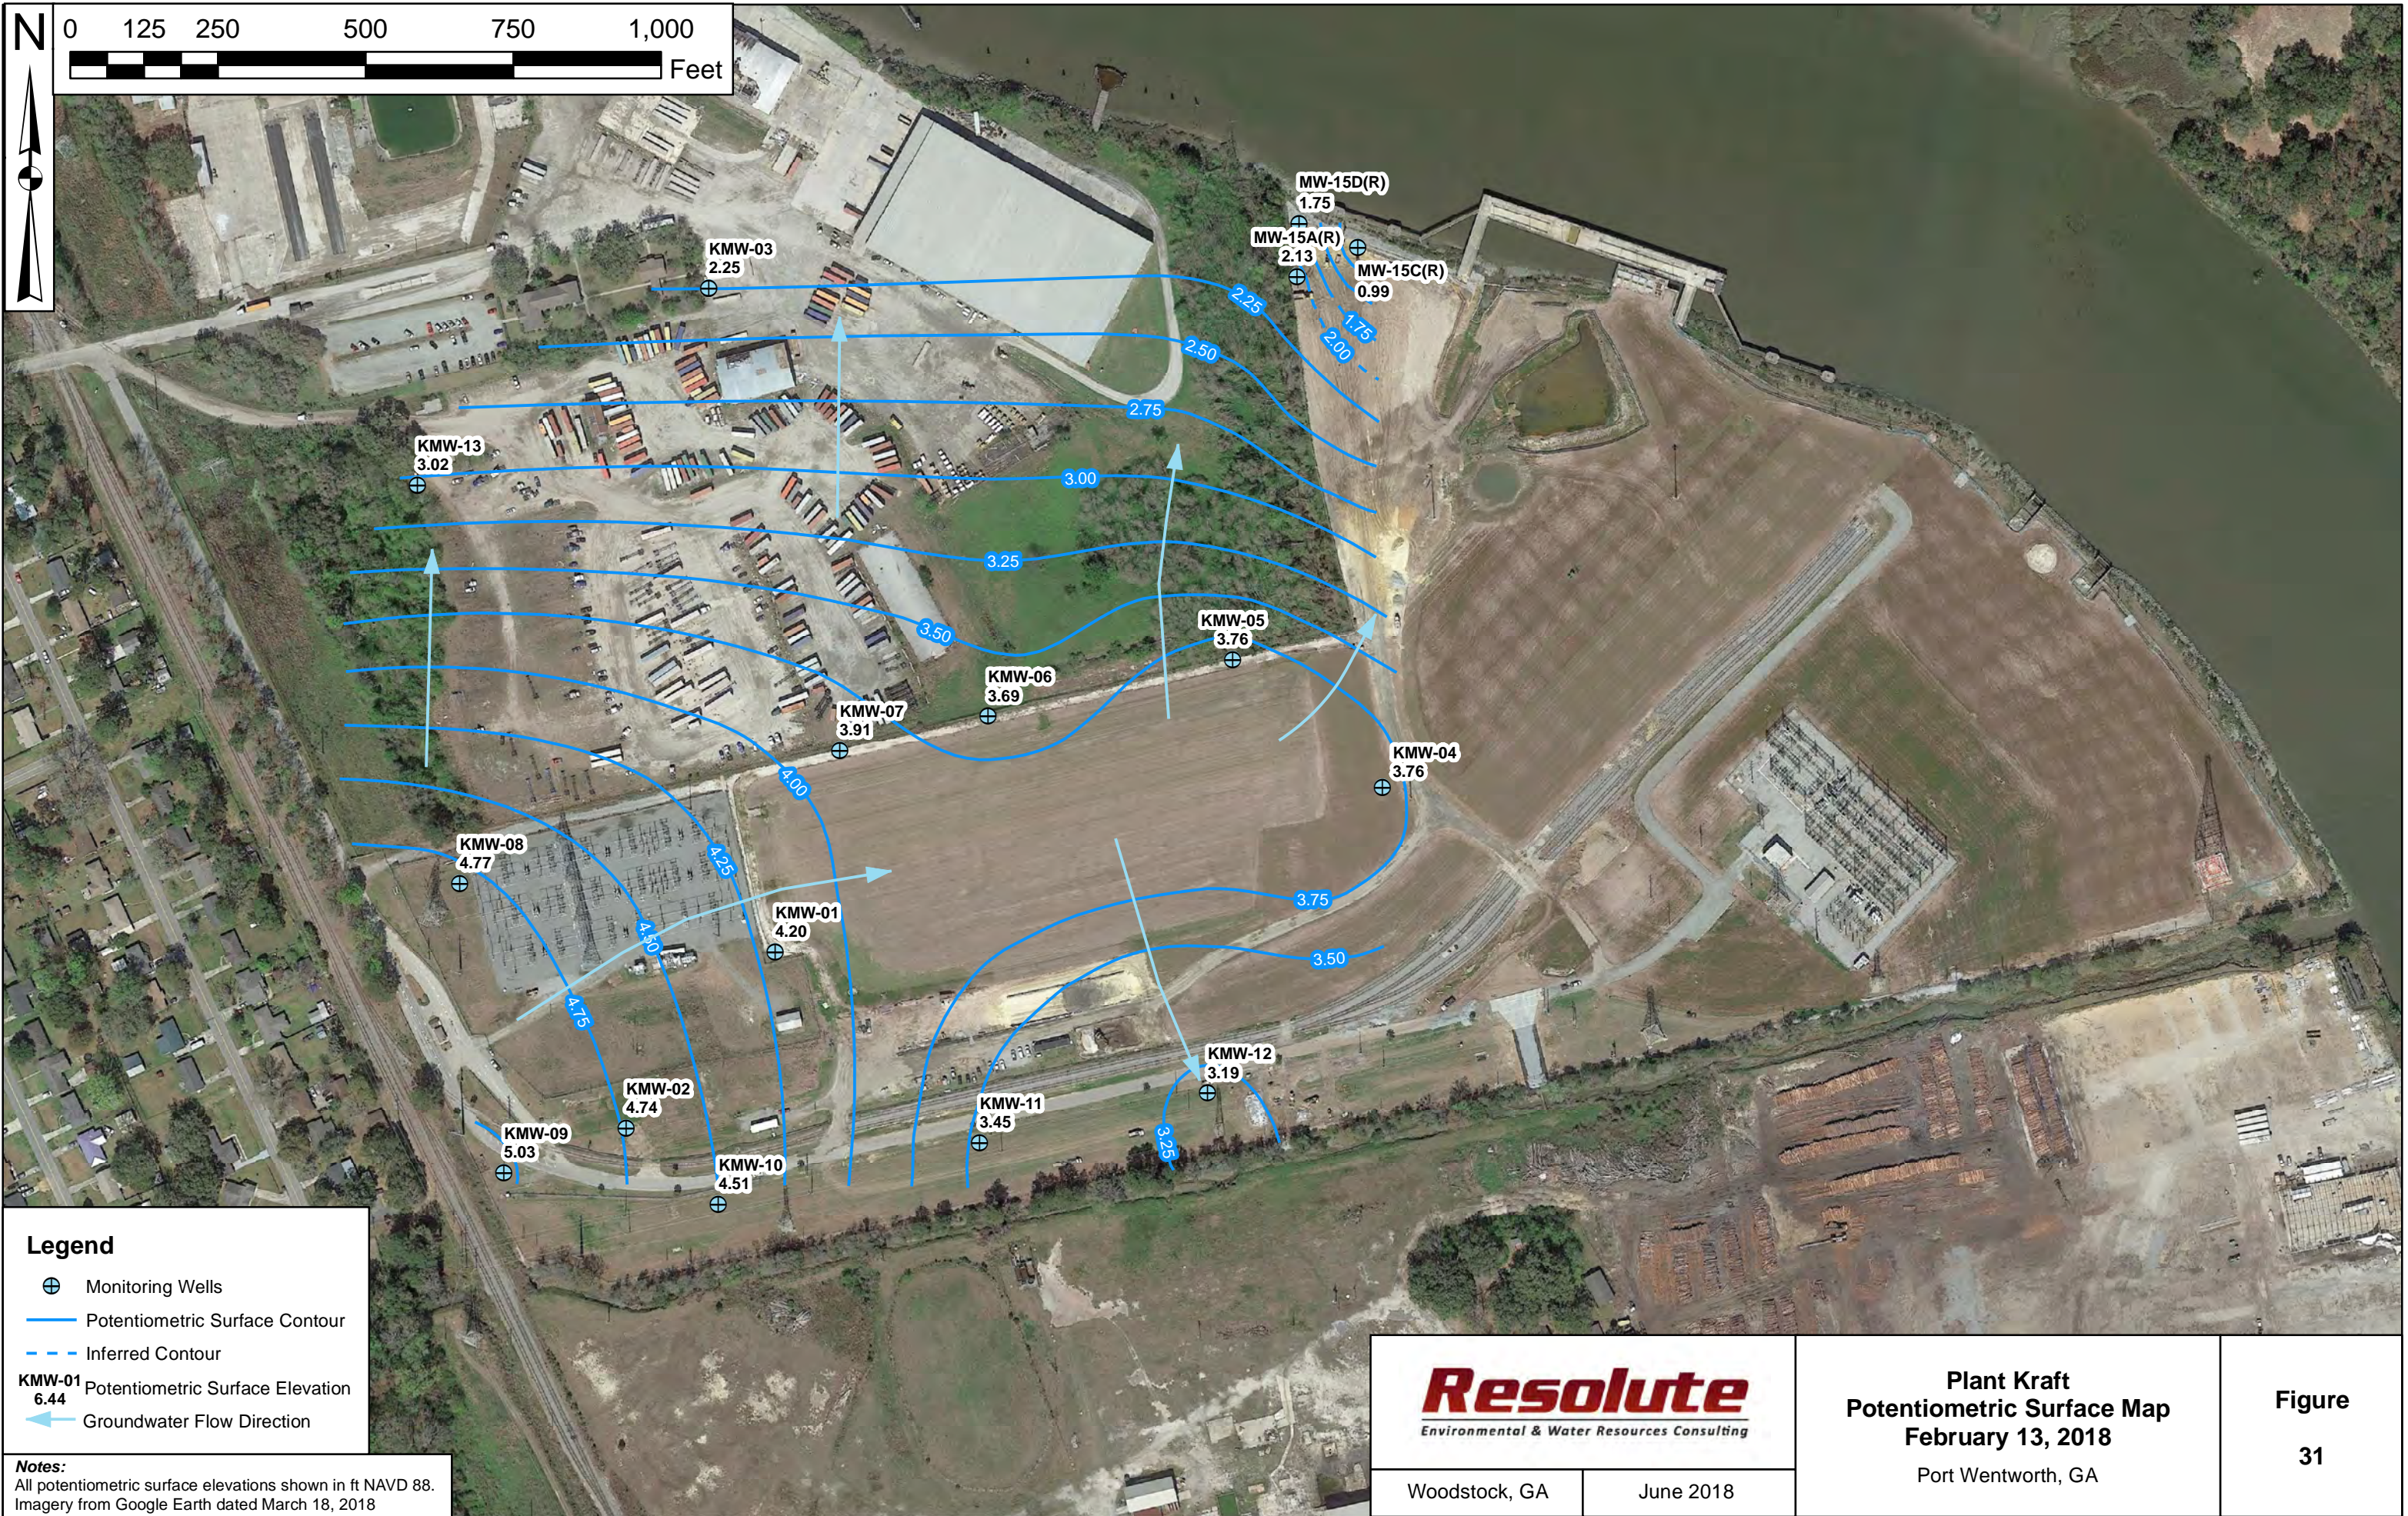
**Figure
30**

The August 2017 potentiometric surface map (Figure 30) illustrates a change in groundwater flow direction in the area of the former ash pond. On this date, the groundwater flow beneath the former ash pond area was to the south and southeast from groundwater highs at wells KMW-08 and KMW-06. Groundwater flow at the Northern Area HSI Site continued to be to the north and northeast toward the Savannah River.

Based on the change in groundwater flow directions between the 2016/January 2017 potentiometric surface maps (Figures 27 through 29), and the August 2017 and February 2018 potentiometric surface maps (Figures 30 and 31), the arsenic concentrations detected in well KMW-02 appear to have increased before the change in groundwater flow from the north in the August 2017 potentiometric surface map. The extent of arsenic exceeding the Type 1/3 RRS has been delineated by monitoring wells KMW-04 to the east (hydraulically side-gradient), KMW-09 to the west (hydraulically side-gradient), KMW-08 to the north (hydraulically up-gradient), and KMW-10 through KMW-12 to the south (hydraulically downgradient). Analytical results of metals from monitoring wells around the former ash pond area are presented in Table 4, and Figures 19 through 21a.

Based on the groundwater flow directions from the August 2017 and February 2018 potentiometric surface maps (Figures 30 and 31), the radium exceeding the 5 pCi/L drinking water standard in groundwater has been delineated by monitoring wells KMW-04 to the east (hydraulically side-gradient), KMW-02 and -08 to the west (hydraulically side-gradient), and KMW-11 and -12 to the south (hydraulically down-gradient). An increase in the radium concentration in KMW-12 in February 2018 resulted in a concentration slightly above 5 pCi/L. The well was resampled on May 7, 2018, to verify this concentration. The May 2018 radium concentration in KMW-12 was less than 5 pCi/L at a concentration of 4.24 pCi/L, and consistent with the concentration from August 2017. In October 2018, this trend was confirmed with results from KMW-12 at 3.79 pCi/L. As shown in Table 5, the laboratory uncertainty from radium groundwater analysis ranges from +/- 0.56 to +/- 2.68 pCi/L, with the average uncertainty for KMW-12 being +/- 1.33 pCi/L. At these very low concentrations, the laboratory uncertainty when performing radium groundwater analyses may have resulted in the February 2018 radium result in KMW-12 exceeding the drinking water standard of 5 pCi/L.
